# Access Compliance Report

## Public Rights-of-Way

### (Curb Ramps)

| Intersection ID: 47087 | Main Street: MARVIN_RD | Cross Street: COVENTRY_COURT_LN | Location: NW |

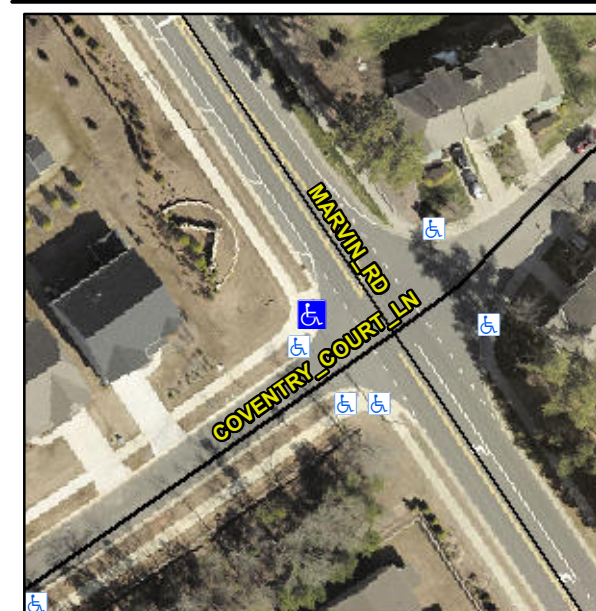
| ADA ID: 7F3BED181D5E | Ramp Type: Perp | Initial Pass/Fail: Fail | Overall Compliance: No |
| Severity Score: 13.75 | | | |

**R304.2.2, R304.5.3**

| Compliance | Description | Data | Compliance | Description | Data |
|---|---|---|---|---|---|
| N/A | Ramp Length (in) | 101.0 | No | Ramp Slope (%) | 8.6 |
| Yes | Ramp Width (in) | 59.0 | No | Ramp XSlope (%) | 4.1 |

**Remove & Replace Entire Ramp.**

Total Cost: \$ 1850.00
