Access Compliance Report

Public Rights-of-Way

(Curb Ramps)

Intersection ID: 10037823	Main Street: SHARON_RD_WEST	Cross Street: N/A	Location: NW
ADA ID: 7F430704E15D	Ramp Type: PerpDiag	Initial Pass/Fail: Fail	Overall Compliance: No
Severity Score: 22.5			
Codes/Mitigation Info/Possible Solution		Field Measurements/Component Compliance

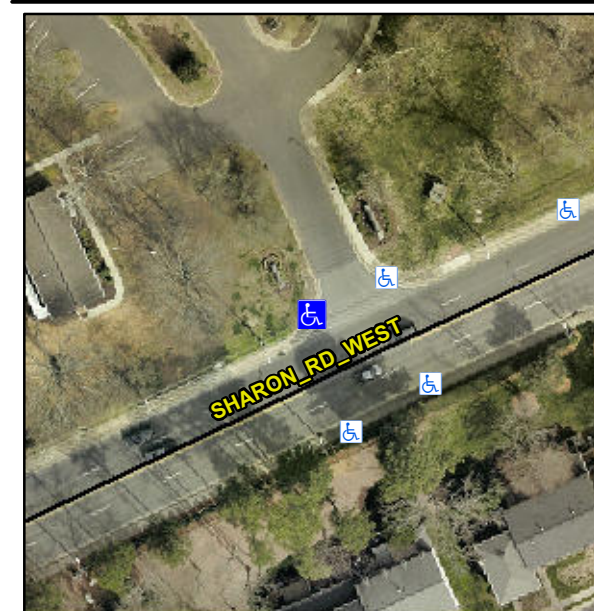
Compliance	Description	Data	Compliance	Description	Data
N/A	Ramp Length (in)	59.0	No	Ramp Slope (%)	10.9
No	Ramp Width (in)	47.0	No	Ramp XSlope (%)	3.5
N/A	Flare Type LT	N/A	N/A	Flare Type RT	N/A
N/A	Flare Slope LT (%)	N/A	N/A	Flare Slope RT (%)	N/A
N/A	Flare Traversable LT?	N/A	N/A	Flare Traversable RT?	N/A
N/A	Landing Length (in)	N/A	N/A	DWS Provided?	N/A
N/A	Landing Width (in)	N/A	N/A	DWS Contrast?	N/A
N/A	Landing Slope (%)	N/A	N/A	DWS Length (in)	N/A
N/A	Landing X Slope (%)	N/A	N/A	DWS Full Width?	N/A
N/A	Landing Curb? (Y/N)	N/A	N/A	DWS Offset (in)	N/A
N/A	Shared Landing?	N/A			
N/A	Gutter Ponding?	N/A	N/A	Gutter Slope (%)	N/A
N/A	Gutter Lip Ht (in)	N/A	N/A	Gutter X Slope (%)	N/A
N/A	Painted X Walk1?	No	N/A	Painted X Walk2?	No
	X Walk 1 Direction	To S		X Walk 2 Direction	To E
N/A	X Walk 1 Width (in)	N/A	N/A	X Walk 2 Width (in)	N/A
	X Walk 1 Slope (%)	2.5		X Walk 2 Slope (%)	5.8
	X Walk 1 X Slope (%)	5.3		X Walk 2 X Slope (%)	1.9

N/A	Ramp inside XWalk1?	N/A	N/A	Ramp inside XWalk2?	N/A
	Road Slope (%)	1.1	N/A	Clear Space?	N/A
	Road X Slope (%)	4.0	N/A	Clear Space to XWalk (in)	N/A
N/A	Any Obstructions?	N/A	N/A	Storm Grate/Utility Hazard?	N/A
	Obstruction Type			Storm Grate/Utility Type	
		N/A			N/A
			Yes	Surface Condition? (G/P)	Good

Remove & Replace Curb Ramp With Two New Directional Ramps or Equivalent.
