# Access Compliance Report

## Public Rights-of-Way

### (Curb Ramps)

Intersection ID: 16828	Main Street: BUCKNELL_AV	Cross Street: SELWYN_AV	Location: SE
ADA ID: 7F454081A52F	Ramp Type: Perp	Initial Pass/Fail: Fail	Overall Compliance: No
Severity Score: 12.5			
Codes/Mitigation Info/Possible Solution		Field Measurements/Component Compliance

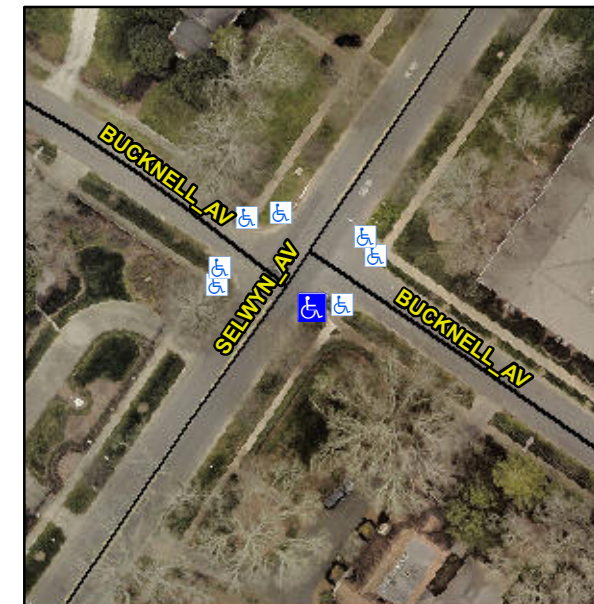
Compliance	Description	Data	Compliance	Description	Data
N/A	Ramp Length (in)	86.0	No	Ramp Slope (%)	8.4
Yes	Ramp Width (in)	48.0	Yes	Ramp XSlope (%)	0.7
N/A	Flare Type LT	N/A	N/A	Flare Type RT	N/A
N/A	Flare Slope LT (%)	N/A	N/A	Flare Slope RT (%)	N/A
N/A	Flare Traversable LT?	N/A	N/A	Flare Traversable RT?	N/A
N/A	Landing Length (in)	N/A	N/A	DWS Provided?	N/A
N/A	Landing Width (in)	N/A	N/A	DWS Contrast?	N/A
N/A	Landing Slope (%)	N/A	N/A	DWS Length (in)	N/A
N/A	Landing X Slope (%)	N/A	N/A	DWS Full Width?	N/A
N/A	Landing Curb? (Y/N)	N/A	N/A	DWS Offset (in)	N/A
N/A	Shared Landing?	N/A			
N/A	Gutter Ponding?	N/A	N/A	Gutter Slope (%)	N/A
N/A	Gutter Lip Ht (in)	N/A	N/A	Gutter X Slope (%)	N/A
N/A	Painted X Walk1?	No	N/A	Painted X Walk2?	N/A
	X Walk 1 Direction	To NW		X Walk 2 Direction	N/A
N/A	X Walk 1 Width (in)	N/A	N/A	X Walk 2 Width (in)	N/A
	X Walk 1 Slope (%)	4.8		X Walk 2 Slope (%)	N/A
	X Walk 1 X Slope (%)	0.1		X Walk 2 X Slope (%)	N/A

N/A	Ramp inside XWalk1?	N/A	N/A	Ramp inside XWalk2?	N/A
	Road Slope (%)	N/A	N/A	Clear Space?	N/A
	Road X Slope (%)	N/A	N/A	Clear Space to XWalk (in)	N/A
N/A	Any Obstructions?	N/A	N/A	Storm Grate/Utility Hazard?	N/A
	Obstruction Type			Storm Grate/Utility Type	
		N/A			N/A
		Yes		Surface Condition? (G/P)	Good

Possible Solutions:

**Remove & Replace Entire Ramp.**

**R304.2.2**

**\$ 1850.00**
