Access Compliance Report

Public Rights-of-Way

(Curb Ramps)

Intersection ID: 7381	Main Street: MAPLEGROVE_DR	Cross Street: N_HOSKINS_RD	Location: SE
ADA ID: 7F4B54EFB7FE	Ramp Type: Perp	Initial Pass/Fail: Fail	Overall Compliance: No
Severity Score: 36.25			
Codes/Mitigation Info/Possible Solution		Field Measurements/Component Compliance

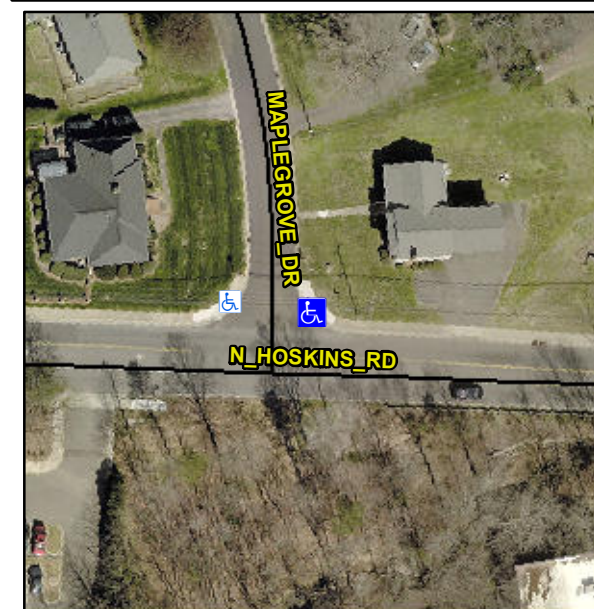
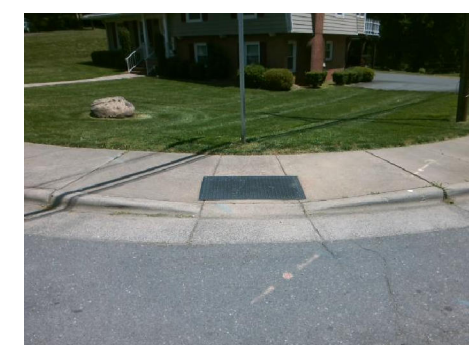
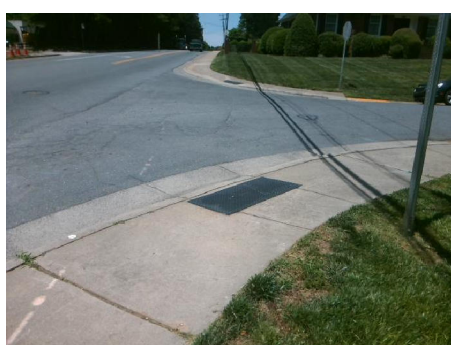
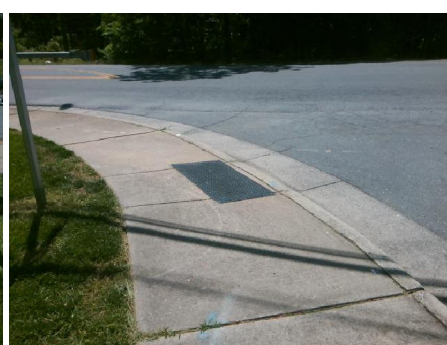
R304.5.1, R304.5.3

Compliance	Description	Data	Compliance	Description	Data
N/A	Ramp Length (in)	59.0	Yes	Ramp Slope (%)	8.2
No	Ramp Width (in)	31.5	No	Ramp XSlope (%)	2.8
N/A	Flare Type LT	N/A	N/A	Flare Type RT	N/A
N/A	Flare Slope LT (%)	N/A	N/A	Flare Slope RT (%)	N/A
N/A	Flare Traversable LT?	N/A	N/A	Flare Traversable RT?	N/A
N/A	Landing Length (in)	N/A	N/A	DWS Provided?	N/A
N/A	Landing Width (in)	N/A	N/A	DWS Contrast?	N/A
N/A	Landing Slope (%)	N/A	N/A	DWS Length (in)	N/A
N/A	Landing X Slope (%)	N/A	N/A	DWS Full Width?	N/A
N/A	Landing Curb? (Y/N)	N/A	N/A	DWS Offset (in)	N/A
N/A	Shared Landing?	N/A			
N/A	Gutter Ponding?	N/A	N/A	Gutter Slope (%)	N/A
N/A	Gutter Lip Ht (in)	N/A	N/A	Gutter X Slope (%)	N/A
N/A	Painted X Walk1?	No	N/A	Painted X Walk2?	N/A
	X Walk 1 Direction	To NW		X Walk 2 Direction	N/A
N/A	X Walk 1 Width (in)	N/A	N/A	X Walk 2 Width (in)	N/A
	X Walk 1 Slope (%)	6.1		X Walk 2 Slope (%)	N/A
	X Walk 1 X Slope (%)	3.2		X Walk 2 X Slope (%)	N/A

N/A	Ramp inside XWalk1?	N/A	N/A	Ramp inside XWalk2?	N/A
	Road Slope (%)	N/A	N/A	Clear Space?	N/A
	Road X Slope (%)	N/A	N/A	Clear Space to XWalk (in)	N/A
N/A	Any Obstructions?	N/A	N/A	Storm Grate/Utility Hazard?	N/A
	Obstruction Type			Storm Grate/Utility Type	
		N/A			N/A
			Yes	Surface Condition? (G/P)	Good

Possible Solutions:

Remove & Replace Entire Ramp.
