# Access Compliance Report

## Public Rights-of-Way

### (Curb Ramps)

Intersection ID: 47442	Main Street: OROFINO_CT	Cross Street: KALISPELL_LN	Location: SW
ADA ID: 7F525907535D	Ramp Type: PerpDiag	Initial Pass/Fail: Fail	Overall Compliance: No
Severity Score: 13.75			
Codes/Mitigation Info/Possible Solution		Field Measurements/Component Compliance

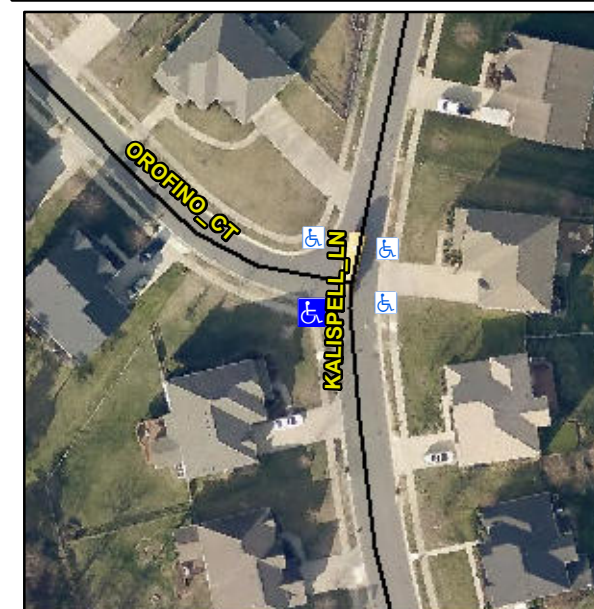
**Not Found, R304.2.2, R304.5.3**

Compliance	Description	Data	Compliance	Description	Data
N/A	Ramp Length (in)	47.0	No	Ramp Slope (%)	9.2
Yes	Ramp Width (in)	48.0	No	Ramp XSlope (%)	4.8
N/A	Flare Type LT	N/A	N/A	Flare Type RT	N/A
N/A	Flare Slope LT (%)	N/A	N/A	Flare Slope RT (%)	N/A
N/A	Flare Traversable LT?	N/A	N/A	Flare Traversable RT?	N/A
N/A	Landing Length (in)	N/A	N/A	DWS Provided?	N/A
N/A	Landing Width (in)	N/A	N/A	DWS Contrast?	N/A
N/A	Landing Slope (%)	N/A	N/A	DWS Length (in)	N/A
N/A	Landing X Slope (%)	N/A	N/A	DWS Full Width?	N/A
N/A	Landing Curb? (Y/N)	N/A	N/A	DWS Offset (in)	N/A
N/A	Shared Landing?	N/A			
N/A	Gutter Ponding?	N/A	N/A	Gutter Slope (%)	N/A
N/A	Gutter Lip Ht (in)	N/A	N/A	Gutter X Slope (%)	N/A
N/A	Painted X Walk1?	No	N/A	Painted X Walk2?	No
	X Walk 1 Direction	To E		X Walk 2 Direction	To N
N/A	X Walk 1 Width (in)	N/A	N/A	X Walk 2 Width (in)	N/A
	X Walk 1 Slope (%)	1.1		X Walk 2 Slope (%)	4.5
	X Walk 1 X Slope (%)	7.6		X Walk 2 X Slope (%)	2.0

N/A	Ramp inside XWalk1?	N/A	N/A	Ramp inside XWalk2?	N/A
	Road Slope (%)	6.6	N/A	Clear Space?	N/A
	Road X Slope (%)	3.2	N/A	Clear Space to XWalk (in)	N/A
N/A	Any Obstructions?	N/A	N/A	Storm Grate/Utility Hazard?	N/A
	Obstruction Type			Storm Grate/Utility Type	
		N/A			N/A
		Yes		Surface Condition? (G/P)	Good

**Remove & Replace Curb Ramp With Two New Directional Ramps or Equivalent.**

Total Cost: \$ 3200.00
