# Access Compliance Report

## Public Rights-of-Way

### (Curb Ramps)

| Intersection ID: 29917 | Main Street: BEMBRIDGE_CT | Cross Street: NORTHRIDGE_DR | Location: SE |

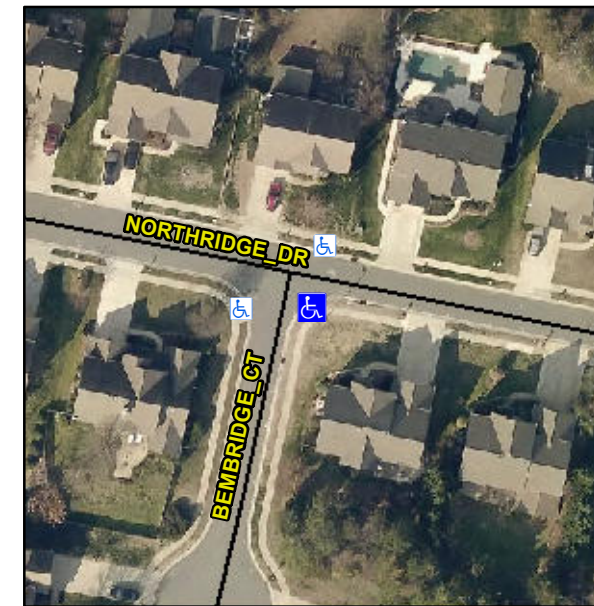
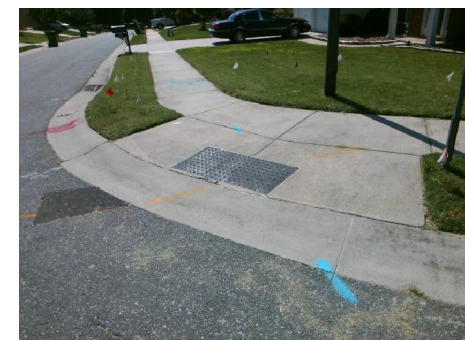
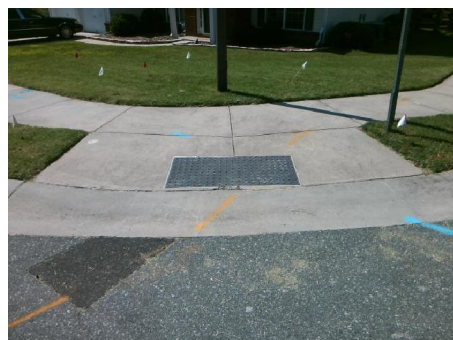
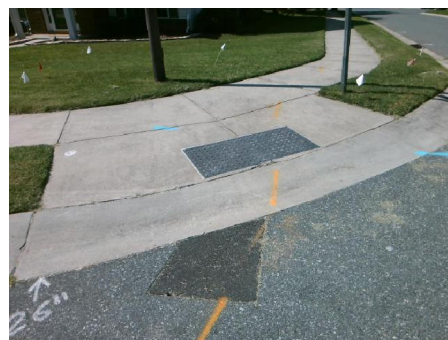
**Not Found, R304.2.1, R304.5.4, R304.5.3**

| Compliance | Description | Data | Compliance | Description | Data |
|---|---|---|---|---|---|
| No | Landing Length (in) | 45.0 | Yes | DWS Provided? | Yes |
| Yes | Gutter Ponding? | No | No | Gutter Slope (%) | 5.1 |
| Yes | Gutter Lip Ht (in) | 0.0 | No | Gutter X Slope (%) | 4.1 |
| | | | No | Curb Slope (%) | 7.0 |

**Remove & Replace Curb Ramp With Two New Directional Ramps or Equivalent. Remove & Replace Gutter.**
