Access Compliance Report Public Rights-of-Way (Curb Ramps)

Intersection ID: 51212 Main Street: PROVIDENCE ROW LN Cross Street: ARDREY_KELL_RD Location: NE ADA ID: 7F5F4FF60253 Ramp Type: Perp Initial Pass/Fail: Fail **Overall Compliance: No** Severity Score: 13.75

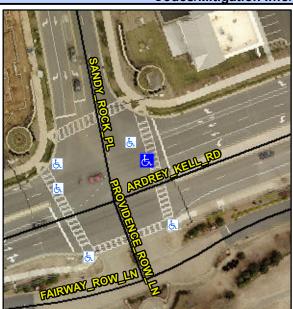
| Field Measurements/Component Compliance | | | | | | | |
|---|---|---|---|---|---|---|--|
| N/A | Ramp Length (in) | 96.0 | No | Ramp | Slope (%) | 8.9 | |
| Yes | Ramp Width (in) | 60.0 | No | Ramp | XSlope (%) | 3.0 | |
