# Access Compliance Report

## Public Rights-of-Way

### (Curb Ramps)

Intersection ID: 12632	Main Street: SEIGLE_AV	Cross Street: SKYLINE_VIEW_WY	Location: W
ADA ID: 7F5FE67E395D	Ramp Type: Directional1	Initial Pass/Fail: Fail	Overall Compliance: No
			Severity Score: 13.75

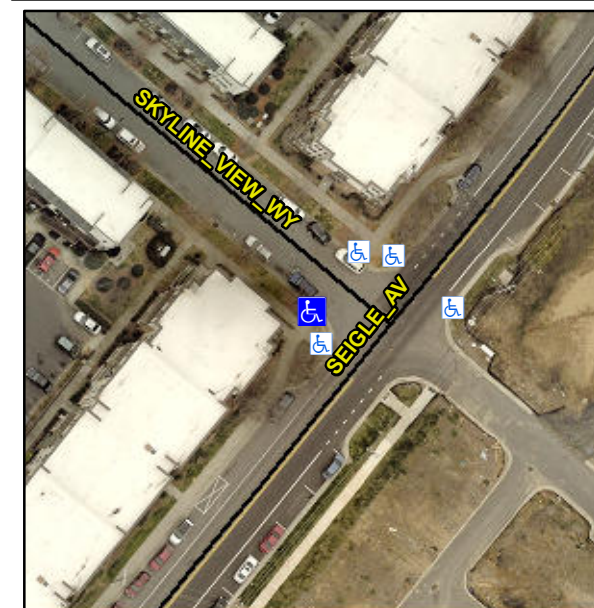
**R304.2.2, R304.5.3**

Compliance	Description	Data	Compliance	Description	Data
N/A	Ramp Length (in)	97.5	N/A	Grade Break?	N/A
Yes	Ramp Width (in)	71.5	N/A	Grade Break Slope (%)	0.0
No	Ramp Slope (%)	9.5	N/A	Grade Break XSlope (%)	0.0
No	Ramp XSlope (%)	2.1			
N/A	Flare Type LT	N/A	N/A	Flare Type RT	N/A
N/A	Flare Slope LT (%)	N/A	N/A	Flare Slope RT (%)	0.0
N/A	Flare Traversable LT?	N/A	N/A	Flare Traversable RT?	N/A
N/A	Landing Length (in)	0.0	N/A	DWS Provided?	N/A
N/A	Landing Width (in)	0.0	N/A	DWS Contrast?	N/A
N/A	Landing Slope (%)	0.0	N/A	DWS Length (in)	N/A
N/A	Landing X Slope (%)	0.0	N/A	DWS Full Width?	N/A
N/A	Landing Curb? (Y/N)	N/A	N/A	DWS Offset LT (in)	N/A
N/A	Shared Landing?	N/A	N/A	DWS Offset RT (in)	N/A
N/A	Gutter Ponding?	0.0	N/A	Gutter Slope (%)	N/A
N/A	Gutter Lip Ht (in)	0.0	N/A	Gutter X Slope (%)	N/A
N/A	Painted X Walk1?	No		Road Slope (%)	3.5
	X Walk 1 Direction	To NE		Road X Slope (%)	3.4
	X Walk 1 Width (in)	N/A		Clear Space?	N/A

X Walk 1 Slope (%)	3.5	N/A	Clear Space to XWalk (in)	N/A
	X Walk 1 X Slope (%)	3.4	N/A	Storm Grate/Utility Hazard?	N/A
N/A	Ramp inside XWalk1?	N/A		Storm Grate/Utility Type	
N/A	Any Obstructions?	N/A			N/A
	Obstruction Type		Yes	Surface Condition? (G/P)	Good
			N/A	Curb Slope (%)	10.3

**Remove & Replace Entire Ramp.**
