Access Compliance Report

Public Rights-of-Way

(Curb Ramps)

Intersection ID: 10228	Main Street: E_35TH_ST	Cross Street: N_ALEXANDER_ST	Location: S
ADA ID: 7F6FC84AD837	Ramp Type: Perp	Initial Pass/Fail: Fail	Overall Compliance: No
Severity Score: 26.25			
Codes/Mitigation Info/Possible Solution		Field Measurements/Component Compliance

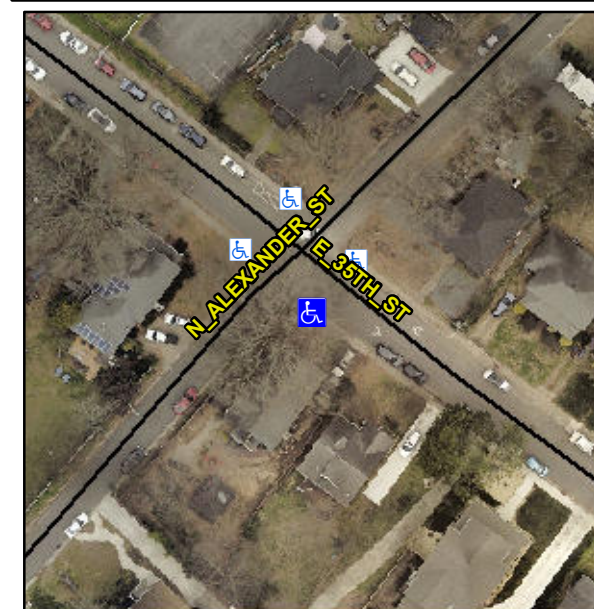
R304.2.2, R304.5.3

Compliance	Description	Data	Compliance	Description	Data
N/A	Ramp Length (in)	47.0	No	Ramp Slope (%)	14.0
Yes	Ramp Width (in)	48.0	No	Ramp XSlope (%)	2.1
N/A	Flare Type LT	N/A	N/A	Flare Type RT	N/A
N/A	Flare Slope LT (%)	N/A	N/A	Flare Slope RT (%)	N/A
N/A	Flare Traversable LT?	N/A	N/A	Flare Traversable RT?	N/A
N/A	Landing Length (in)	N/A	N/A	DWS Provided?	N/A
N/A	Landing Width (in)	N/A	N/A	DWS Contrast?	N/A
N/A	Landing Slope (%)	N/A	N/A	DWS Length (in)	N/A
N/A	Landing X Slope (%)	N/A	N/A	DWS Full Width?	N/A
N/A	Landing Curb? (Y/N)	N/A	N/A	DWS Offset (in)	N/A
N/A	Shared Landing?	N/A			
N/A	Gutter Ponding?	N/A	N/A	Gutter Slope (%)	N/A
N/A	Gutter Lip Ht (in)	N/A	N/A	Gutter X Slope (%)	N/A
N/A	Painted X Walk1?	No	N/A	Painted X Walk2?	N/A
	X Walk 1 Direction	To NW		X Walk 2 Direction	N/A
N/A	X Walk 1 Width (in)	N/A	N/A	X Walk 2 Width (in)	N/A
	X Walk 1 Slope (%)	0.1		X Walk 2 Slope (%)	N/A
	X Walk 1 X Slope (%)	3.3		X Walk 2 X Slope (%)	N/A

N/A	Ramp inside XWalk1?	N/A	N/A	Ramp inside XWalk2?	N/A
	Road Slope (%)	N/A	N/A	Clear Space?	N/A
	Road X Slope (%)	N/A	N/A	Clear Space to XWalk (in)	N/A
N/A	Any Obstructions?	N/A	N/A	Storm Grate/Utility Hazard?	N/A
	Obstruction Type			Storm Grate/Utility Type	
		N/A			N/A
		Yes		Surface Condition? (G/P)	Good

Possible Solutions:

Remove & Replace Entire Ramp.
