## Access Compliance Report Public Rights-of-Way (Curb Ramps)

Intersection ID: 15676Main Street: CHEROKEE\_PLCross Street: CHEROKEE\_RDLocation:NWADA ID: 7F738DE25DD9Ramp Type: PerpDiagInitial Pass/Fail: FailOverall Compliance: NoSeverity Score:25

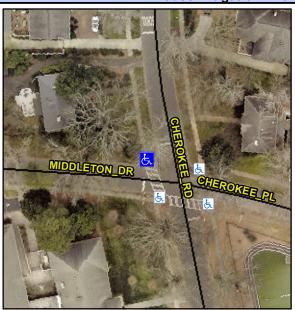
rieiu ivieasui e	inents/C	ompo	nent Comphance	
Comp	Compliance Description		Compliance Description		Data
N/A	Ramp Length (in)	75.0	No	Ramp Slope (%)	13.1
Yes	Ramp Width (in)	50.0	Yes	Ramp XSlope (%)	1.6
N/A	Flare Type LT	N/A	N/A	Flare Type RT	N/A
N/A	Flare Slope LT (%)	N/A	N/A	Flare Slope RT (%)	N/A
N/A	Flare Traversable LT?	N/A	N/A	Flare Traversable RT?	N/A
N/A	Landing Length (in)	N/A	N/A	DWS Provided?	N/A
N/A	Landing Width (in)	N/A	N/A	DWS Contrast?	N/A
N/A	Landing Slope (%)	N/A	N/A	DWS Length (in)	N/A
N/A	Landing X Slope (%)	N/A	N/A	DWS Full Width?	N/A
N/A	Landing Curb? (Y/N)	N/A	N/A	DWS Offset (in)	N/A
N/A	Shared Landing?	N/A			
N/A	Gutter Ponding?	N/A	N/A	Gutter Slope (%)	N/A
N/A	Gutter Lip Ht (in)	N/A	N/A	Gutter X Slope (%)	N/A
N/A	Painted X Walk1?	Yes	N/A	Painted X Walk2?	No
	X Walk 1 Direction	To S		X Walk 2 Direction	To E
N/A	X Walk 1 Width (in)	108.0	N/A	X Walk 2 Width (in)	N/A
	X Walk 1 Slope (%)	4.6		X Walk 2 Slope (%)	3.4

X Walk 1 X Slope (%)	0.5		X Walk 2 X Slope (%)	1.2
N/A	Ramp inside XWalk1?	Yes	N/A	Ramp inside XWalk2?	N/A
	Road Slope (%)	0.1	N/A	Clear Space?	N/A
	Road X Slope (%)	5.9	N/A	Clear Space to XWalk (in)	N/A
N/A	Any Obstructions?	N/A	N/A	Storm Grate/Utility Hazard?	N/A
	Obstruction Type		l	Storm Grate/Utility Type	
		N/A			N/A
			Yes	Surface Condition? (G/P)	Good

Possible Solutions:	Co			
Remove & Replace Curb Ramp With Two New Directional Ramps or				
	N/A			
	N/A			
	N/A			
Surveyor Notes:	N/A			
N/A	N/A			
	N/A			
	N/A			
	N/A			
PROW/ADA:	N/A			
Not Found, R304.2.2	N/A

Total Cost: \$ 3200.00
