# Access Compliance Report

## Public Rights-of-Way

### (Curb Ramps)

| Intersection ID: 3490 | Main Street: PRESERVATION_POINTE_DR | Cross Street: TRANQUILLITY_DR | Location: NW |

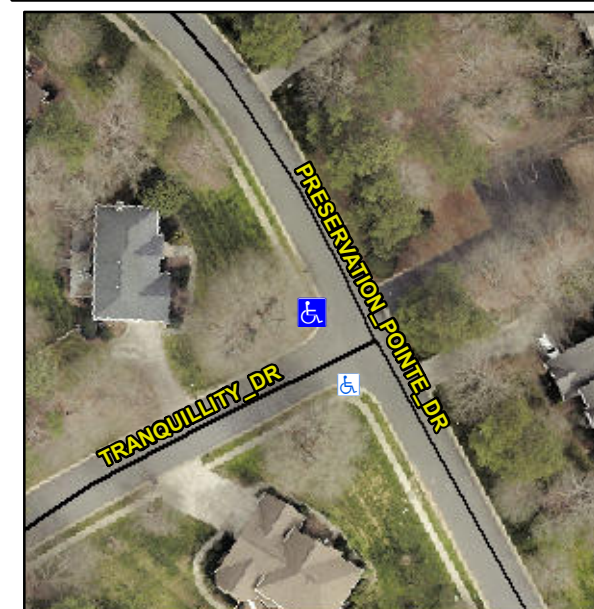
| ADA ID: 7F740559B434 | Ramp Type: Perp | Initial Pass/Fail: Fail | Overall Compliance: No |
| Severity Score: 22.5 | | | |

**Not Found, R304.5.1, R304.2.2, R304.5.3**

| Compliance | Description | Data | Compliance | Description | Data |
|---|---|---|---|---|---|
| N/A | Ramp Length (in) | 48.0 | No | Ramp Slope (%) | 10.0 |
| No | Ramp Width (in) | 44.0 | No | Ramp XSlope (%) | 4.3 |

**Remove & Replace Entire Ramp.**

Total Cost: \$ 1850.00
