Access Compliance Report

Public Rights-of-Way

(Curb Ramps)

Intersection ID: 7793	Main Street: JEFF_ADAMS_DR	Cross Street: STATESVILLE_AV	Location: SE
ADA ID: 7F79EC991DDD	Ramp Type: Perp	Initial Pass/Fail: Fail	Overall Compliance: No
Severity Score: 12.5			
Codes/Mitigation Info/Possible Solution		Field Measurements/Component Compliance

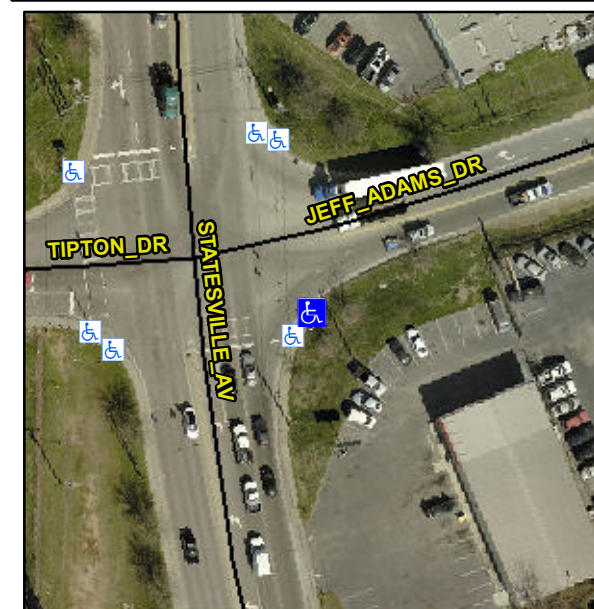
Not Found, R304.2.2

Compliance	Description	Data	Compliance	Description	Data
N/A	Ramp Length (in)	60.0	No	Ramp Slope (%)	9.3
Yes	Ramp Width (in)	48.0	Yes	Ramp XSlope (%)	1.7
N/A	Flare Type LT	N/A	N/A	Flare Type RT	N/A
N/A	Flare Slope LT (%)	N/A	N/A	Flare Slope RT (%)	N/A
N/A	Flare Traversable LT?	N/A	N/A	Flare Traversable RT?	N/A
N/A	Landing Length (in)	N/A	N/A	DWS Provided?	N/A
N/A	Landing Width (in)	N/A	N/A	DWS Contrast?	N/A
N/A	Landing Slope (%)	N/A	N/A	DWS Length (in)	N/A
N/A	Landing X Slope (%)	N/A	N/A	DWS Full Width?	N/A
N/A	Landing Curb? (Y/N)	N/A	N/A	DWS Offset (in)	N/A
N/A	Shared Landing?	N/A			
N/A	Gutter Ponding?	N/A	N/A	Gutter Slope (%)	N/A
N/A	Gutter Lip Ht (in)	N/A	N/A	Gutter X Slope (%)	N/A
N/A	Painted X Walk1?	No	N/A	Painted X Walk2?	N/A
	X Walk 1 Direction	To N		X Walk 2 Direction	N/A
N/A	X Walk 1 Width (in)	N/A	N/A	X Walk 2 Width (in)	N/A
	X Walk 1 Slope (%)	1.9		X Walk 2 Slope (%)	N/A
	X Walk 1 X Slope (%)	0.6		X Walk 2 X Slope (%)	N/A

N/A	Ramp inside XWalk1?	N/A	N/A	Ramp inside XWalk2?	N/A
	Road Slope (%)	N/A	N/A	Clear Space?	N/A
	Road X Slope (%)	N/A	N/A	Clear Space to XWalk (in)	N/A
N/A	Any Obstructions?	N/A	N/A	Storm Grate/Utility Hazard?	N/A
	Obstruction Type			Storm Grate/Utility Type	
		N/A			N/A
			Yes	Surface Condition? (G/P)	Good

Remove & Replace Entire Ramp.
