# Access Compliance Report

## Public Rights-of-Way

### (Curb Ramps)

| Intersection ID: 27495 | Main Street: BALLANTYNE COMMONS PY | Cross Street: NORTH COMMUNITY HOUSE RD | Location: SW |

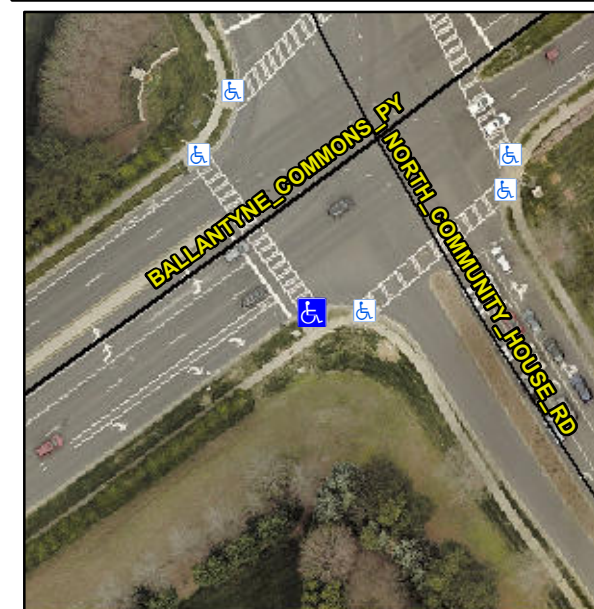
| ADA ID: 7F7D462D54CE | Ramp Type: Perp | Initial Pass/Fail: Pass | Overall Compliance: No |
| Severity Score: 0.25 | | | |

**Not Found, R304.5.3, R304.2.1,  
R304.2.2-Perp, R304.3.2-Para**

| Compliance | Description | Data | Compliance | Description | Data |
|---|---|---|---|---|---|
| Yes | Ramp Width (in) | 48.0 | No | Ramp XSlope (%) | 2.5 |
| No | Landing Width (in) | 47.0 | Yes | DWS Contrast? | Yes |
| No | Landing Slope (%) | 3.0 | Yes | DWS Length (in) | 24.0 |
| No | Landing X Slope (%) | 3.5 | Yes | DWS Full Width? | Yes |
| Yes | Gutter Lip Ht (in) | 0.0 | No | Gutter X Slope (%) | 4.8 |

Possible Solutions:

**Remove & Replace Entire Ramp.  
Remove & Replace Gutter.**

Total Cost: \$ 2600.00
