# Access Compliance Report

## Public Rights-of-Way

### (Curb Ramps)

Intersection ID: 27708	Main Street: BREM_LN	Cross Street: LEDERER_AV	Location: NE
ADA ID: 7F854D41528F	Ramp Type: Perp	Initial Pass/Fail: Fail	Overall Compliance: No
			Severity Score: 21.25

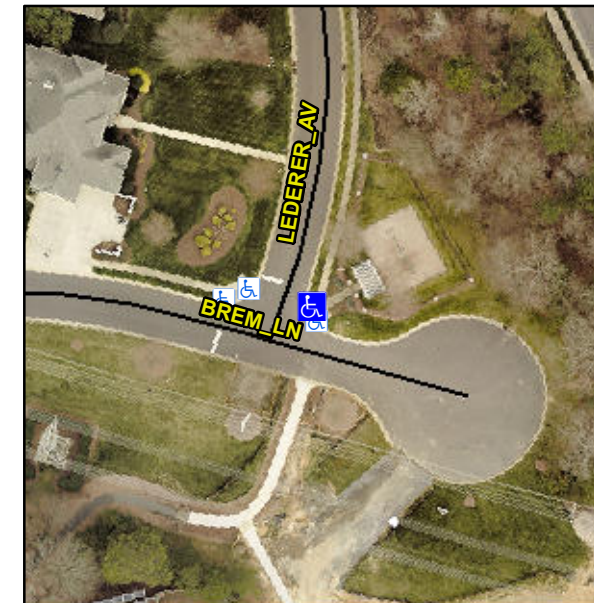
**Not Found, R304.5.1, R304.5.3**

Compliance	Description	Data	Compliance	Description	Data
N/A	Ramp Length (in)	51.0	Yes	Ramp Slope (%)	6.7
No	Ramp Width (in)	47.0	No	Ramp XSlope (%)	5.8
N/A	Flare Type LT	N/A	N/A	Flare Type RT	N/A
N/A	Flare Slope LT (%)	N/A	N/A	Flare Slope RT (%)	N/A
N/A	Flare Traversable LT?	N/A	N/A	Flare Traversable RT?	N/A
N/A	Landing Length (in)	N/A	N/A	DWS Provided?	N/A
N/A	Landing Width (in)	N/A	N/A	DWS Contrast?	N/A
N/A	Landing Slope (%)	N/A	N/A	DWS Length (in)	N/A
N/A	Landing X Slope (%)	N/A	N/A	DWS Full Width?	N/A
N/A	Landing Curb? (Y/N)	N/A	N/A	DWS Offset (in)	N/A
N/A	Shared Landing?	N/A			
N/A	Gutter Ponding?	N/A	N/A	Gutter Slope (%)	N/A
N/A	Gutter Lip Ht (in)	N/A	N/A	Gutter X Slope (%)	N/A
N/A	Painted X Walk1?	No	N/A	Painted X Walk2?	N/A
	X Walk 1 Direction	To NW		X Walk 2 Direction	N/A
N/A	X Walk 1 Width (in)	N/A	N/A	X Walk 2 Width (in)	N/A
	X Walk 1 Slope (%)	5.1		X Walk 2 Slope (%)	N/A
	X Walk 1 X Slope (%)	4.3		X Walk 2 X Slope (%)	N/A

**Remove & Replace Entire Ramp.**

Total Cost: \$ 1850.00
