# Access Compliance Report

## Public Rights-of-Way

### (Curb Ramps)

| Intersection ID: 18706 | Main Street: JESTER_LN | Cross Street: BRAEBURN_RD | Location: SW |

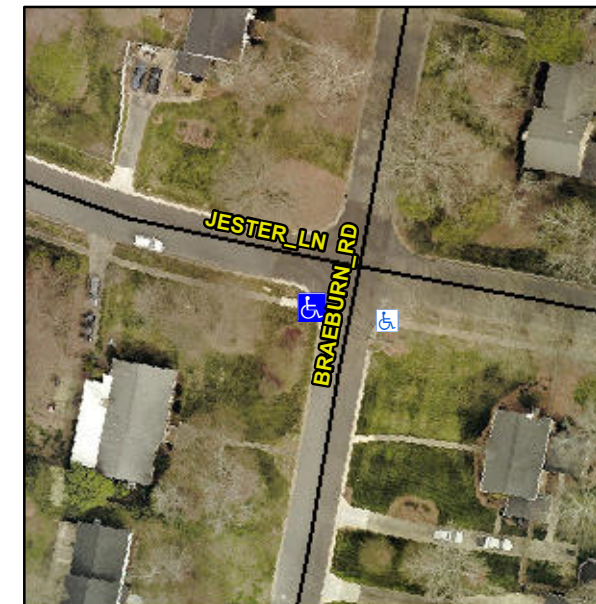
**Not Found, R304.2.2**

| Compliance | Description | Data | Compliance | Description | Data |
|---|---|---|---|---|---|
| N/A | Ramp Length (in) | 62.0 | No | Ramp Slope (%) | 11.0 |
| Yes | Ramp Width (in) | 48.0 | Yes | Ramp XSlope (%) | 1.9 |

**Remove & Replace Curb Ramp With Two New Directional Ramps or Equivalent.**
