Access Compliance Report

Public Rights-of-Way

(Curb Ramps)

Intersection ID: 25705	Main Street: REA_RD	Cross Street: SUNDANCER_LN	Location: NE
ADA ID: 7F8BCB9A91B4	Ramp Type: Perp	Initial Pass/Fail: Fail	Overall Compliance: No
Severity Score: 13.75			
Codes/Mitigation Info/Possible Solution		Field Measurements/Component Compliance

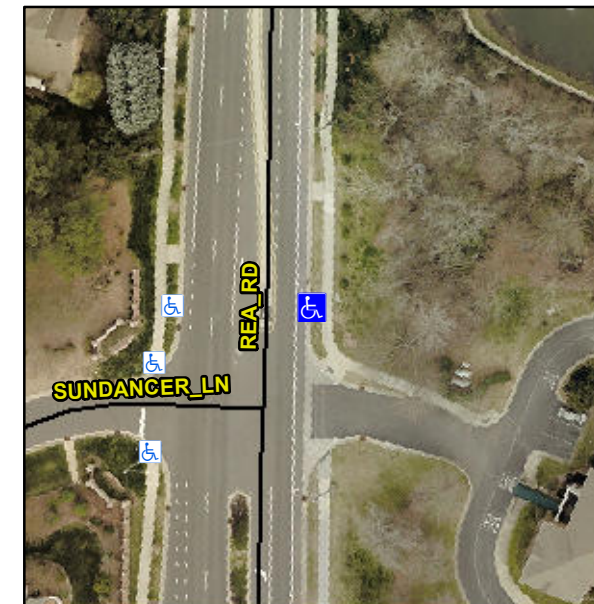
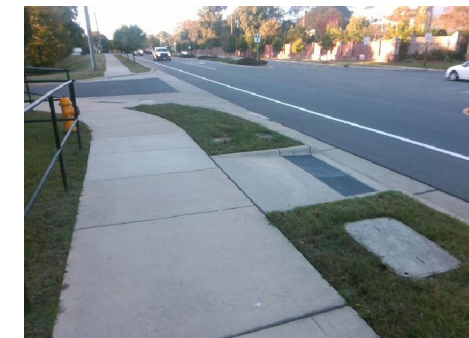
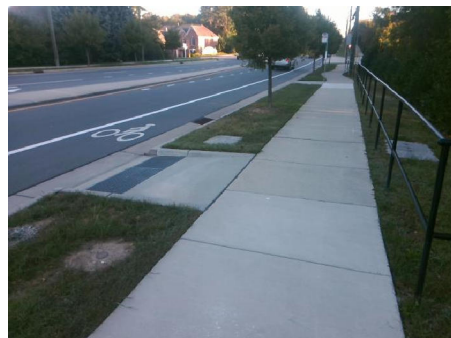
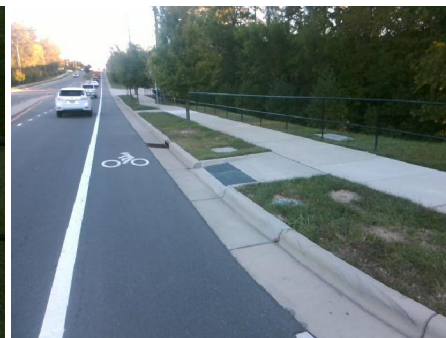
Not Found, R304.2.2, R304.5.3

Compliance	Description	Data	Compliance	Description	Data
N/A	Ramp Length (in)	72.0	No	Ramp Slope (%)	8.5
Yes	Ramp Width (in)	82.0	No	Ramp XSlope (%)	4.4
N/A	Flare Type LT	N/A	N/A	Flare Type RT	N/A
N/A	Flare Slope LT (%)	N/A	N/A	Flare Slope RT (%)	N/A
N/A	Flare Traversable LT?	N/A	N/A	Flare Traversable RT?	N/A
N/A	Landing Length (in)	N/A	N/A	DWS Provided?	N/A
N/A	Landing Width (in)	N/A	N/A	DWS Contrast?	N/A
N/A	Landing Slope (%)	N/A	N/A	DWS Length (in)	N/A
N/A	Landing X Slope (%)	N/A	N/A	DWS Full Width?	N/A
N/A	Landing Curb? (Y/N)	N/A	N/A	DWS Offset (in)	N/A
N/A	Shared Landing?	N/A			
N/A	Gutter Ponding?	N/A	N/A	Gutter Slope (%)	N/A
N/A	Gutter Lip Ht (in)	N/A	N/A	Gutter X Slope (%)	N/A
N/A	Painted X Walk1?	No	N/A	Painted X Walk2?	N/A
	X Walk 1 Direction	To W		X Walk 2 Direction	N/A
N/A	X Walk 1 Width (in)	N/A	N/A	X Walk 2 Width (in)	N/A
	X Walk 1 Slope (%)	2.3		X Walk 2 Slope (%)	N/A
	X Walk 1 X Slope (%)	3.3		X Walk 2 X Slope (%)	N/A

N/A	Ramp inside XWalk1?	N/A	N/A	Ramp inside XWalk2?	N/A
	Road Slope (%)	N/A	N/A	Clear Space?	N/A
	Road X Slope (%)	N/A	N/A	Clear Space to XWalk (in)	N/A
N/A	Any Obstructions?	N/A	N/A	Storm Grate/Utility Hazard?	N/A
	Obstruction Type			Storm Grate/Utility Type	
		N/A			N/A
			Yes	Surface Condition? (G/P)	Good

Remove & Replace Entire Ramp.
