# Access Compliance Report

## Public Rights-of-Way

### (Curb Ramps)

Intersection ID: 23558	Main Street: HAMLIN_PARK_DR	Cross Street: PARK_RD	Location: NW
ADA ID: 7F8FFF784953	Ramp Type: BlendTrans1	Initial Pass/Fail: Pass	Overall Compliance: No
		Severity Score: 12.5

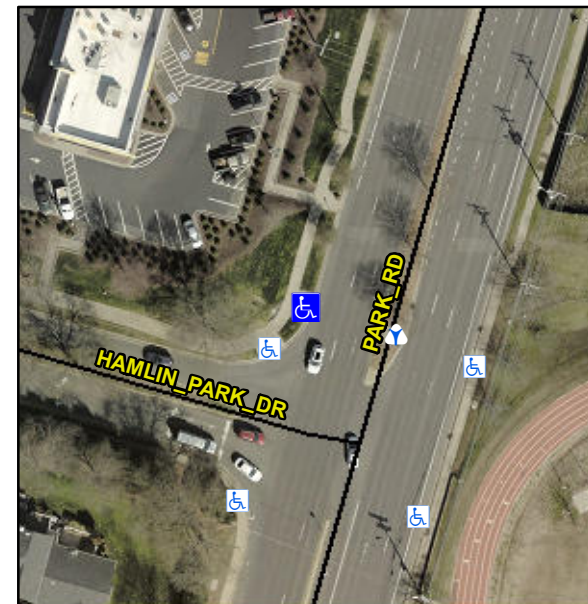
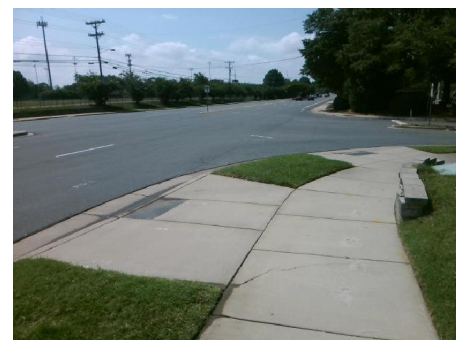
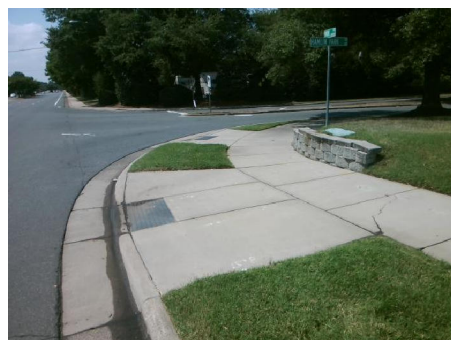
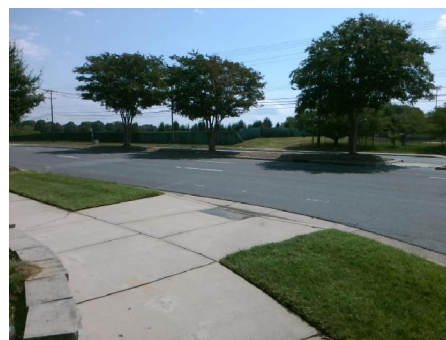
Compliance	Description	Data	Compliance	Description	Data
N/A	Ramp Length (in)	<b>97.0</b>	Yes	BlendTrans Slope (%)	<b>3.5</b>
Yes	Ramp Width (in)	<b>48.0</b>	Yes	BlendTrans XSlope (%)	<b>1.5</b>
N/A	Flare Type LT	<b>Sloped</b>	N/A	Flare Type RT	<b>Sloped</b>
N/A	Flare Slope LT (%)	<b>3.5</b>	N/A	Flare Slope RT (%)	<b>6.7</b>
N/A	Flare Traversable LT?	<b>No</b>	N/A	Flare Traversable RT?	<b>No</b>
Yes	Landing Length (in)	<b>70.0</b>	Yes	DWS Provided?	<b>Yes</b>
Yes	Landing Width (in)	<b>48.0</b>	Yes	DWS Contrast?	<b>Yes</b>
Yes	Landing Slope (%)	<b>0.6</b>	Yes	DWS Length (in)	<b>24.0</b>
No	Landing X Slope (%)	<b>2.3</b>	Yes	DWS Full Width?	<b>Yes</b>
N/A	Landing Curb? (Y/N)	<b>Yes</b>	Yes	DWS Offset (in)	<b>0.0</b>
N/A	Shared Landing?	<b>No</b>			
Yes	Gutter Ponding?	<b>No</b>	No	Gutter Slope (%)	<b>6.1</b>
No	Gutter Lip Ht (in)	<b>0.3</b>	Yes	Gutter X Slope (%)	<b>1.3</b>
N/A	Painted X Walk1?	<b>No</b>	N/A	Painted X Walk2?	<b>N/A</b>

X Walk 1 Direction	<b>To SE</b>		X Walk 2 Direction	<b>N/A</b>
	X Walk 1 Width (in)	<b>N/A</b>		X Walk 2 Width (in)	<b>N/A</b>
	X Walk 1 Slope (%)	<b>3.4</b>		X Walk 2 Slope (%)	<b>N/A</b>
	X Walk 1 X Slope (%)	<b>0.7</b>		X Walk 2 X Slope (%)	<b>N/A</b>
N/A	Ramp inside XWalk1?	<b>N/A</b>	N/A	Ramp inside XWalk2?	<b>N/A</b>
	Road Slope (%)	<b>0.7</b>		Clear Space?	<b>Yes</b>
	Road X Slope (%)	<b>3.4</b>	N/A	Clear Space to XWalk (in)	<b>N/A</b>
Yes	Any Obstructions?	<b>No</b>	Yes	Storm Grate/Utility Hazard?	<b>No</b>
	Obstruction Type			Storm Grate/Utility Type	
		<b>N/A</b>			<b>N/A</b>
			Yes	Surface Condition? (G/P)	<b>Good</b>
			Yes	Curb Slope (%)	<b>2.7</b>

**Remove & Replace Landing.  
Remove & Replace Gutter.**

**R304.5.3, R302.7.2, R304.5.4**
