# Access Compliance Report

## Public Rights-of-Way

### (Curb Ramps)

Intersection ID: 15864	Main Street: LEROY_ST	Cross Street: ST_JAMES_PL	Location: W
ADA ID: 7F96E15D6992	Ramp Type: Perp	Initial Pass/Fail: Pass	Overall Compliance: No
		Severity Score: 7.5

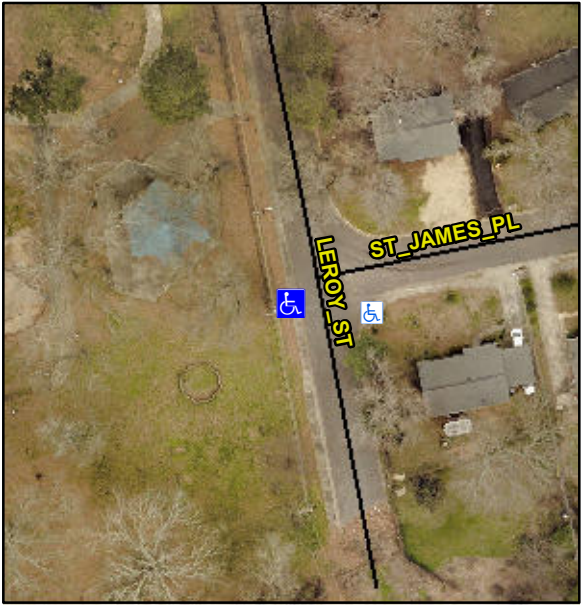
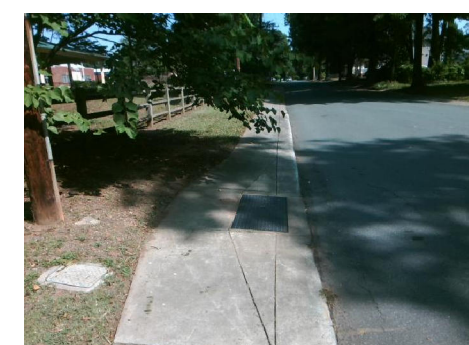
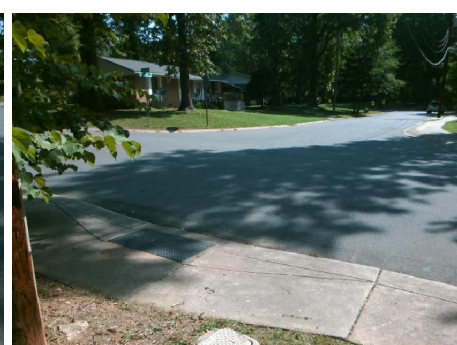
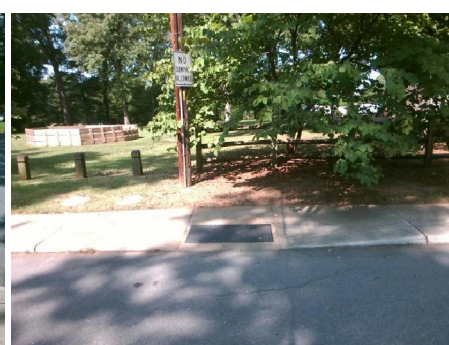
Possible Solutions:		<b>Compliance</b>	<b>Description</b>	<b>Data</b>
	Remove & Replace Entire Ramp.		N/A	Ramp Length (in)	35.0
	Remove & Replace Gutter.		Yes	Ramp Width (in)	53.5
			N/A	Flare Type LT	Sloped
			N/A	Flare Slope LT (%)	0.6
			N/A	Flare Traversable LT?	Yes
			No	Landing Length (in)	35.5
			Yes	Landing Width (in)	53.5
			No	Landing Slope (%)	3.0
			Yes	Landing X Slope (%)	2.5
<p>Surveyor Notes:</p> <p>N/A</p> <p>PROW/ADA:</p> <p>R304.2.1, R304.2.2-Perp, R304.3.2-Para, R305.1.4, R305.2, R304.5.4</p>			N/A	Flare Type RT	N/A
			Yes	Flare Slope RT (%)	7.7
			N/A	Flare Traversable RT?	Yes
			Yes	DWS Provided?	Yes
			Yes	DWS Contrast?	Yes
			Yes	DWS Length (in)	25.5
			No	DWS Full Width?	No
			N/A	DWS Offset (in)	9.5
			N/A	Shared Landing?	No
			Yes	Gutter Ponding?	No
<p>Total Cost:</p> <p>\$ 2600.00</p>			Yes	Gutter X Slope (%)	1.6

N/A	Painted X Walk1?	N/A
				X Walk 1 Direction	To E
			N/A	X Walk 1 Width (in)	N/A
				X Walk 1 Slope (%)	4.8
				X Walk 1 X Slope (%)	2.5
			N/A	Ramp inside XWalk1?	N/A
			N/A	Ramp inside XWalk2?	N/A
			N/A	Road Slope (%)	N/A
			N/A	Road X Slope (%)	N/A
			Yes	Any Obstructions?	No
				Obstruction Type	
			N/A		
			Yes	Storm Grate/Utility Hazard?	No
				Storm Grate/Utility Type	
			N/A		N/A
			Yes	Surface Condition? (G/P)	Good
