Access Compliance Report

Public Rights-of-Way (Curb Ramps)

Intersection ID: 32102	Main Street: BLUE_HERON_DR	Cross Street: CASTLE_PINE_CT	Location: NE
ADA ID: 7F9CD24F72CD	Ramp Type: Directional2	Initial Pass/Fail: Fail	Overall Compliance: No
		Severity Score: 25

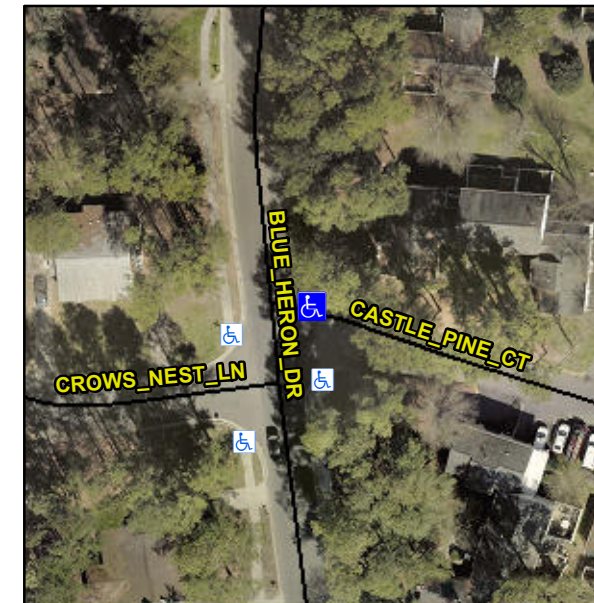
R304.2.2, R304.5.3

Compliance	Description	Data	Compliance	Description	Data
N/A	Ramp Length (in)	87.0	N/A	Grade Break?	N/A
Yes	Ramp Width (in)	53.0	N/A	Grade Break Slope (%)	0.0
No	Ramp Slope (%)	10.6	N/A	Grade Break XSlope (%)	0.0
No	Ramp XSlope (%)	5.5			
N/A	Flare Type LT	N/A	N/A	Flare Type RT	N/A
N/A	Flare Slope LT (%)	N/A	N/A	Flare Slope RT (%)	0.0
N/A	Flare Traversable LT?	N/A	N/A	Flare Traversable RT?	N/A
N/A	Landing Length (in)	0.0	N/A	DWS Provided?	N/A
N/A	Landing Width (in)	0.0	N/A	DWS Contrast?	N/A
N/A	Landing Slope (%)	0.0	N/A	DWS Length (in)	N/A
N/A	Landing X Slope (%)	0.0	N/A	DWS Full Width?	N/A
N/A	Landing Curb? (Y/N)	N/A	N/A	DWS Offset LT (in)	N/A
N/A	Shared Landing?	N/A	N/A	DWS Offset RT (in)	N/A
N/A	Gutter Ponding?	0.0	N/A	Gutter Slope (%)	N/A
N/A	Gutter Lip Ht (in)	0.0	N/A	Gutter X Slope (%)	N/A
N/A	Painted X Walk1?	No		Road Slope (%)	1.0
	X Walk 1 Direction	To SE		Road X Slope (%)	1.9
	X Walk 1 Width (in)	N/A		Clear Space?	N/A

X Walk 1 Slope (%)	1.0	N/A	Clear Space to XWalk (in)	N/A
	X Walk 1 X Slope (%)	1.9	N/A	Storm Grate/Utility Hazard?	N/A
N/A	Ramp inside XWalk1?	N/A		Storm Grate/Utility Type	
N/A	Any Obstructions?	N/A			N/A
	Obstruction Type		Yes	Surface Condition? (G/P)	Good
			N/A	Curb Slope (%)	4.0

Remove & Replace Entire Ramp.
