# Access Compliance Report

## Public Rights-of-Way

### (Curb Ramps)

Intersection ID: 13868	Main Street: DELTA_LANDING_RD	Cross Street: E_W_T_HARRIS_BV	Location: E
ADA ID: 7FA4D7570D04	Ramp Type: PerpDiag	Initial Pass/Fail: Fail	Overall Compliance: No
			Severity Score: 21.25

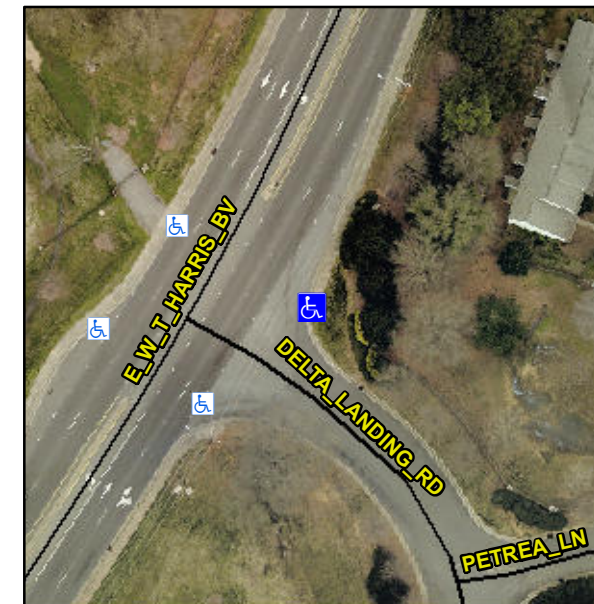
**Not Found, R304.5.1, R304.2.2**

Compliance	Description	Data	Compliance	Description	Data
N/A	Ramp Length (in)	60.0	No	Ramp Slope (%)	9.4
No	Ramp Width (in)	42.0	Yes	Ramp XSlope (%)	1.3
N/A	Flare Type LT	N/A	N/A	Flare Type RT	N/A
N/A	Flare Slope LT (%)	N/A	N/A	Flare Slope RT (%)	N/A
N/A	Flare Traversable LT?	N/A	N/A	Flare Traversable RT?	N/A
N/A	Landing Length (in)	N/A	N/A	DWS Provided?	N/A
N/A	Landing Width (in)	N/A	N/A	DWS Contrast?	N/A
N/A	Landing Slope (%)	N/A	N/A	DWS Length (in)	N/A
N/A	Landing X Slope (%)	N/A	N/A	DWS Full Width?	N/A
N/A	Landing Curb? (Y/N)	N/A	N/A	DWS Offset (in)	N/A
N/A	Shared Landing?	N/A			
N/A	Gutter Ponding?	N/A	N/A	Gutter Slope (%)	N/A
N/A	Gutter Lip Ht (in)	N/A	N/A	Gutter X Slope (%)	N/A
N/A	Painted X Walk1?	No	N/A	Painted X Walk2?	No
	X Walk 1 Direction	To NW		X Walk 2 Direction	To SW
N/A	X Walk 1 Width (in)	N/A	N/A	X Walk 2 Width (in)	N/A
	X Walk 1 Slope (%)	0.9		X Walk 2 Slope (%)	2.2
	X Walk 1 X Slope (%)	3.7		X Walk 2 X Slope (%)	0.6

N/A	Ramp inside XWalk1?	N/A	N/A	Ramp inside XWalk2?	N/A
	Road Slope (%)	3.1	N/A	Clear Space?	N/A
	Road X Slope (%)	2.5	N/A	Clear Space to XWalk (in)	N/A
N/A	Any Obstructions?	N/A	N/A	Storm Grate/Utility Hazard?	N/A
	Obstruction Type			Storm Grate/Utility Type	
		N/A			N/A
			Yes	Surface Condition? (G/P)	Good

**Remove & Replace Curb Ramp With Two New Directional Ramps or Equivalent.**

Total Cost: \$ 3200.00
