Access Compliance Report

Public Rights-of-Way

(Curb Ramps)

Intersection ID: 17587	Main Street: KNICKERBOCKER_DR	Cross Street: MELBA_DR	Location: S
ADA ID: 7FA8F565DB00	Ramp Type: Perp	Initial Pass/Fail: Pass	Overall Compliance: No
Codes/Mitigation Info/Possible Solution		Field Measurements/Component Compliance

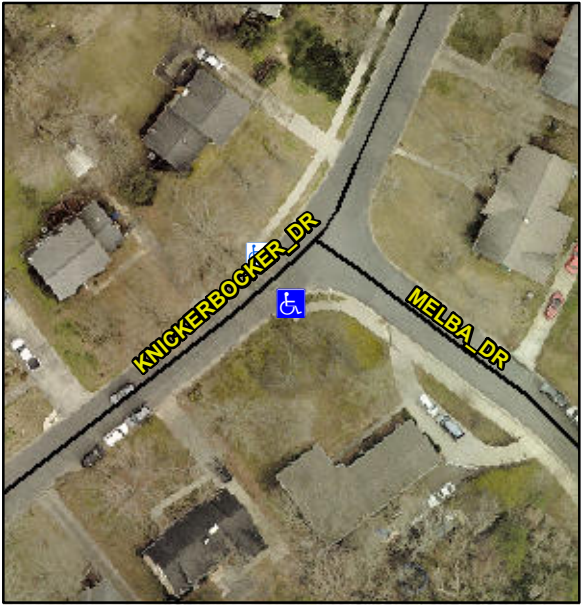
Possible Solutions:	Compliance	Description	Data	Compliance	Description	Data
	Remove & Replace Entire Ramp. Remove & Replace Gutter.	N/A	Ramp Length (in)	48.0	Yes	Ramp Slope (%)	5.1
<p>Surveyor Notes:</p> <p>N/A</p> <p>PROW/ADA:</p> <p>Not Found, R304.5.3</p>		Yes	Ramp Width (in)	48.0	Yes	Ramp XSlope (%)	0.3
		N/A	Flare Type LT	Sloped	N/A	Flare Type RT	N/A
		N/A	Flare Slope LT (%)	6.8	Yes	Flare Slope RT (%)	2.1
		N/A	Flare Traversable LT?	Yes	N/A	Flare Traversable RT?	Yes
		Yes	Landing Length (in)	58.0	Yes	DWS Provided?	Yes
		Yes	Landing Width (in)	48.0	Yes	DWS Contrast?	Yes
		Yes	Landing Slope (%)	1.3	Yes	DWS Length (in)	24.0
		Yes	Landing X Slope (%)	1.9	Yes	DWS Full Width?	Yes
		N/A	Landing Curb? (Y/N)	No	Yes	DWS Offset (in)	2.0
		N/A	Shared Landing?	No			
		Yes	Gutter Ponding?	No	Yes	Gutter Slope (%)	0.2
		Yes	Gutter Lip Ht (in)	0.0	No	Gutter X Slope (%)	3.1
		N/A	Painted X Walk1?	No	N/A	Painted X Walk2?	N/A

X Walk 1 Direction	To N		X Walk 2 Direction	N/A
		N/A	X Walk 1 Width (in)	N/A	N/A	X Walk 2 Width (in)	N/A
			X Walk 1 Slope (%)	2.3		X Walk 2 Slope (%)	N/A
			X Walk 1 X Slope (%)	0.5		X Walk 2 X Slope (%)	N/A
		N/A	Ramp inside XWalk1?	N/A	N/A	Ramp inside XWalk2?	N/A
			Road Slope (%)	N/A	N/A	Clear Space?	Yes
			Road X Slope (%)	N/A	N/A	Clear Space to XWalk (in)	N/A
		Yes	Any Obstructions?	No	Yes	Storm Grate/Utility Hazard?	No
			Obstruction Type			Storm Grate/Utility Type	
					N/A		N/A
					Yes	Surface Condition? (G/P)	Good
