Access Compliance Report

Public Rights-of-Way

(Curb Ramps)

Intersection ID: 27002	Main Street: WALKER_RD	Cross Street: WEDDINGTON_RD	Location: SW
ADA ID: 7FB32AA43867	Ramp Type: Combination1	Initial Pass/Fail: Fail	Overall Compliance: No
		Severity Score: 10

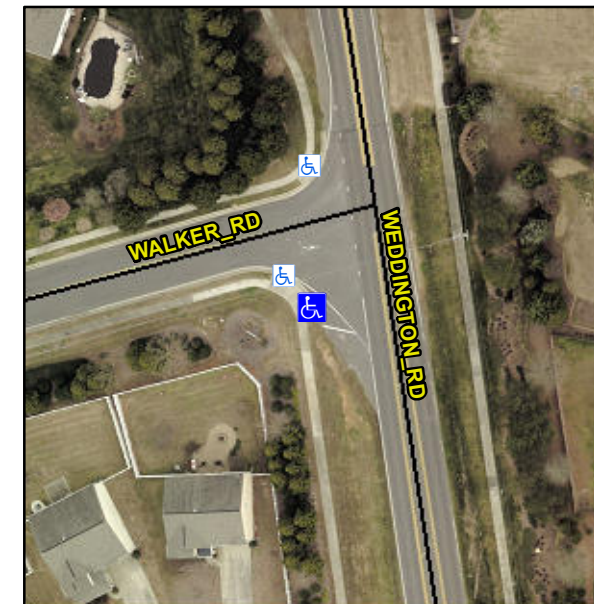
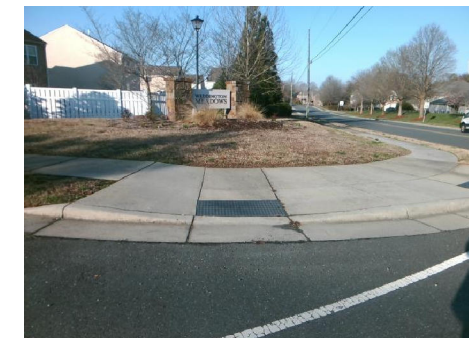
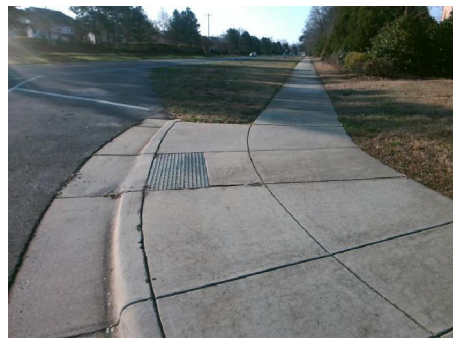
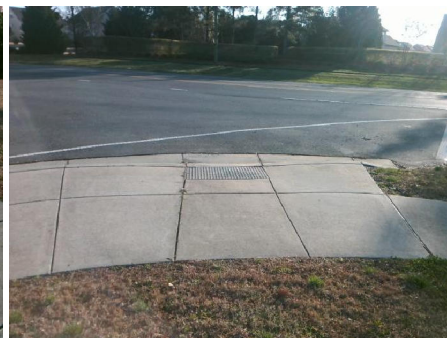
RP & RT RP < 5%

Not Found, R304.5.1, R304.5.3

Compliance	Description	Data	Compliance	Description	Data
N/A	Ramp Length LT (in)	40.0	N/A	Ramp Length RT (in)	37.0
Yes	Ramp Width LT (in)	60.0	Yes	Ramp Width RT (in)	60.0
Yes	Ramp Slope LT (%)	8.0	Yes	Ramp Slope RT (%)	0.8
Yes	Ramp XSlope LT (%)	1.4	No	Ramp XSlope RT (%)	2.5
N/A	Ramp Length (in)	48.0	Yes	Ramp Slope (%)	3.9
No	Ramp Width (in)	46.5	Yes	Ramp XSlope (%)	1.6
N/A	Flare Type LT	N/A	N/A	Flare Type RT	N/A
N/A	Flare Slope LT (%)	N/A	N/A	Flare Slope RT (%)	N/A
N/A	Flare Traversable LT?	N/A	N/A	Flare Traversable RT?	N/A
N/A	Landing Length (in)	N/A	N/A	DWS Provided?	N/A
N/A	Landing Width (in)	N/A	N/A	DWS Contrast?	N/A
N/A	Landing Slope (%)	N/A	N/A	DWS Length (in)	N/A
N/A	Landing X Slope (%)	N/A	N/A	DWS Full Width?	N/A
N/A	Landing Curb? (Y/N)	N/A	N/A	DWS Offset (in)	N/A
N/A	Shared Landing?	N/A			
N/A	Gutter Ponding?	N/A	N/A	Gutter Slope (%)	N/A
N/A	Gutter Lip Ht (in)	N/A	N/A	Gutter X Slope (%)	N/A
N/A	Painted X Walk1?	No	N/A	Painted X Walk2?	N/A

X Walk 1 Direction	To E		X Walk 2 Direction	N/A
	X Walk 1 Width (in)	N/A		X Walk 2 Width (in)	N/A
	X Walk 1 Slope (%)	5.0		X Walk 2 Slope (%)	N/A
	X Walk 1 X Slope (%)	1.9		X Walk 2 X Slope (%)	N/A
N/A	Ramp inside XWalk1?	N/A	N/A	Ramp inside XWalk2?	N/A
	Road Slope (%)	N/A		Clear Space?	N/A
	Road X Slope (%)	N/A	N/A	Clear Space to XWalk (in)	N/A
			N/A	Any Obstruction?	N/A
				Obstruction Type	N/A
			N/A	Storm Grate/Utility Hazard?	N/A
				Storm Grate/Utility Type	N/A
			Yes	Surface Condition? (G/P)	Good
				Curb Slope (%)	12.6

Remove & Replace Entire Ramp.

Total Cost: \$ 1800.00
