Access Compliance Report Public Rights-of-Way (Curb Ramps)

Intersection ID: 27288Main Street: PIPER_STATION_DRCross Street: REA_RDLocation:EADA ID: 7FB7E9F680CBRamp Type: PerpInitial Pass/Fail: FailOverall Compliance: NoSeverity Score:22.5

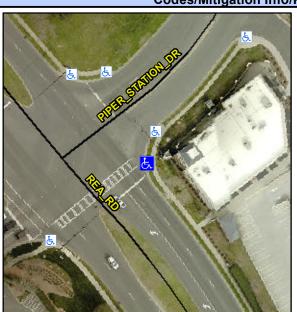
Field Measurements/Component Compliance						
Compl	iance Description	Data	Comp	liance Description	Data	
N/A	Ramp Length (in)	109.0	No	Ramp Slope (%)	11.7	
No	Ramp Width (in)	46.0	No	Ramp XSlope (%)	3.1	
N/A	Flare Type LT	N/A	N/A	Flare Type RT	N/A	
N/A	Flare Slope LT (%)	N/A	N/A	Flare Slope RT (%)	N/A	
N/A	Flare Traversable LT?	N/A	N/A	Flare Traversable RT?	N/A	
N/A	Landing Length (in)	N/A	N/A	DWS Provided?	N/A	
N/A	Landing Width (in)	N/A	N/A	DWS Contrast?	N/A	
N/A	Landing Slope (%)	N/A	N/A	DWS Length (in)	N/A	
N/A	Landing X Slope (%)	N/A	N/A	DWS Full Width?	N/A	
N/A	Landing Curb? (Y/N)	N/A	N/A	DWS Offset (in)	N/A	
N/A	Shared Landing?	N/A				
N/A	Gutter Ponding?	N/A	N/A	Gutter Slope (%)	N/A	
N/A	Gutter Lip Ht (in)	N/A	N/A	Gutter X Slope (%)	N/A	
N/A	Painted X Walk1?	Yes	N/A	Painted X Walk2?	N/A	
	X Walk 1 Direction	To SW		X Walk 2 Direction	N/A	
N/A	X Walk 1 Width (in)	127.0	N/A	X Walk 2 Width (in)	N/A	
	X Walk 1 Slope (%)	4.2		X Walk 2 Slope (%)	N/A

X Walk 1 X Slope (%)	1.0		X Walk 2 X Slope (%)	N/A	
N/A	Ramp inside XWalk1?	No	N/A	Ramp inside XWalk2?	N/A	
	Road Slope (%)	N/A	N/A	Clear Space?	N/A	
	Road X Slope (%)	N/A	N/A	Clear Space to XWalk (in)	N/A	
N/A	Any Obstructions?	N/A	N/A	Storm Grate/Utility Hazard?	N/A	
	Obstruction Type			Storm Grate/Utility Type		
		N/A			N/A	
			Yes	Surface Condition? (G/P)	Good	
Ł.

Possible Solution	
Possible Solutions:	<u>c</u>
Remove & Replace Entire Ramp.	
Restripe Crosswalk.	N
	N
	N
	N
	N
Surveyor Notes:	N
N/A	N
	N
	N
	N
PROW/ADA:	N
Not Found, R304.5.1, R304.2.2,	N
R304.5.3	N
	N
