Access Compliance Report

Public Rights-of-Way

(Curb Ramps)

Intersection ID: 5421	Main Street: SUNSET_RD	Cross Street: OLD_STATESVILLE_RD	Location: W
ADA ID: 7FBBE70E44E6	Ramp Type: Perp	Initial Pass/Fail: Fail	Overall Compliance: No
Severity Score: 21.25			
Codes/Mitigation Info/Possible Solution		Field Measurements/Component Compliance

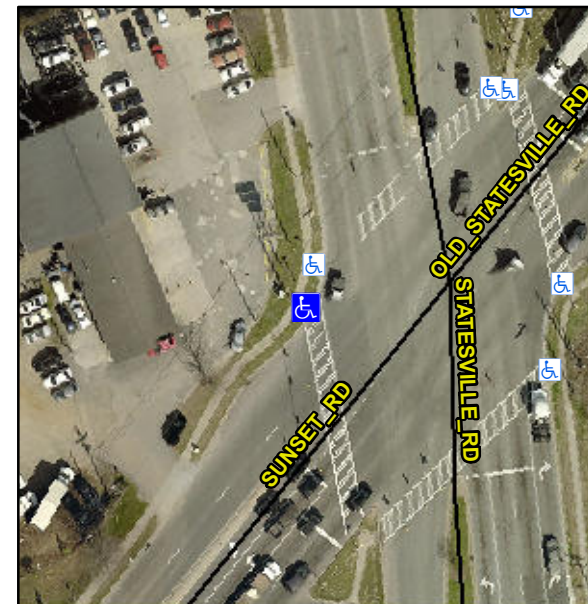
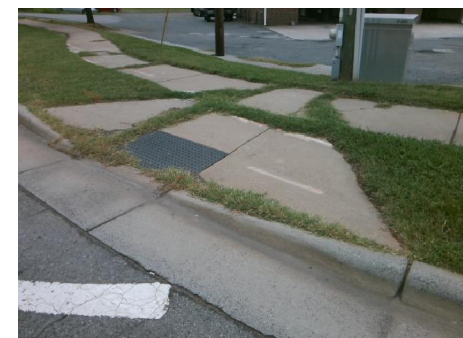
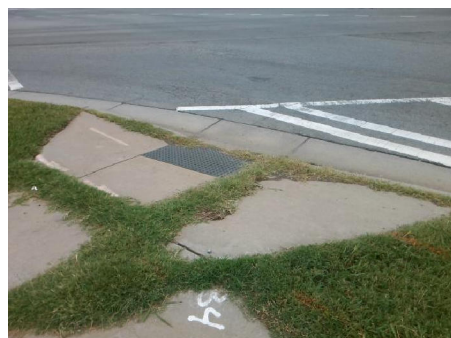
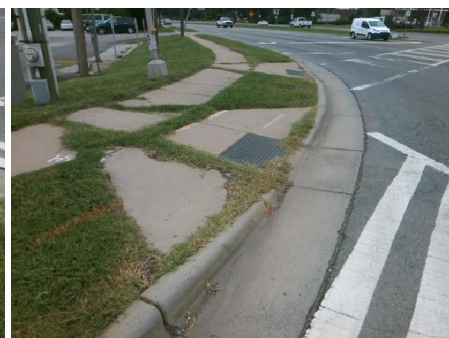
Not Found, R304.5.1, R304.2.2

Compliance	Description	Data	Compliance	Description	Data
N/A	Ramp Length (in)	60.0	No	Ramp Slope (%)	9.8
No	Ramp Width (in)	45.0	Yes	Ramp XSlope (%)	0.3
N/A	Flare Type LT	N/A	N/A	Flare Type RT	N/A
N/A	Flare Slope LT (%)	N/A	N/A	Flare Slope RT (%)	N/A
N/A	Flare Traversable LT?	N/A	N/A	Flare Traversable RT?	N/A
N/A	Landing Length (in)	N/A	N/A	DWS Provided?	N/A
N/A	Landing Width (in)	N/A	N/A	DWS Contrast?	N/A
N/A	Landing Slope (%)	N/A	N/A	DWS Length (in)	N/A
N/A	Landing X Slope (%)	N/A	N/A	DWS Full Width?	N/A
N/A	Landing Curb? (Y/N)	N/A	N/A	DWS Offset (in)	N/A
N/A	Shared Landing?	N/A			
N/A	Gutter Ponding?	N/A	N/A	Gutter Slope (%)	N/A
N/A	Gutter Lip Ht (in)	N/A	N/A	Gutter X Slope (%)	N/A
N/A	Painted X Walk1?	Yes	N/A	Painted X Walk2?	N/A
	X Walk 1 Direction	To S		X Walk 2 Direction	N/A
N/A	X Walk 1 Width (in)	146.0	N/A	X Walk 2 Width (in)	N/A
	X Walk 1 Slope (%)	1.7		X Walk 2 Slope (%)	N/A
	X Walk 1 X Slope (%)	0.3		X Walk 2 X Slope (%)	N/A

N/A	Ramp inside XWalk1?	Yes	N/A	Ramp inside XWalk2?	N/A
	Road Slope (%)	N/A	N/A	Clear Space?	N/A
	Road X Slope (%)	N/A	N/A	Clear Space to XWalk (in)	N/A
N/A	Any Obstructions?	N/A	N/A	Storm Grate/Utility Hazard?	N/A
	Obstruction Type			Storm Grate/Utility Type	
		N/A			N/A
			Yes	Surface Condition? (G/P)	Good

Possible Solutions:

Remove & Replace Entire Ramp.
