Access Compliance Report

Public Rights-of-Way

(Curb Ramps)

Intersection ID: 10746	Main Street: MIRAMAR_DR	Cross Street: PURSER_DR	Location: NE
ADA ID: 7FC3C1C1453E	Ramp Type: Para	Initial Pass/Fail: Fail	Overall Compliance: No
		Severity Score: 12.5

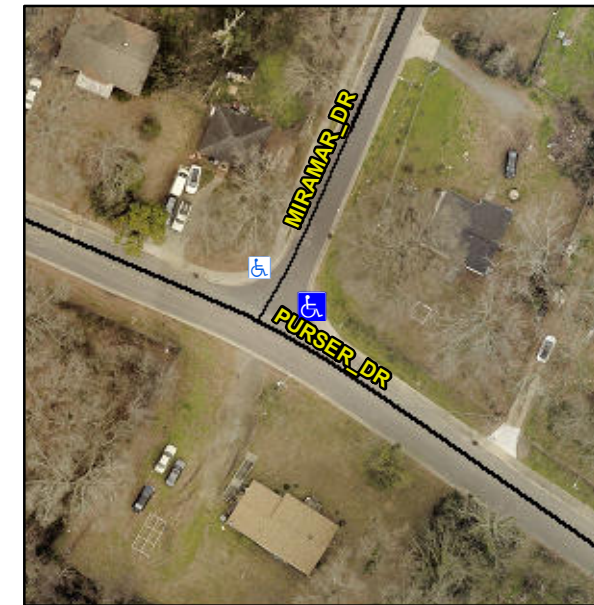
RT RP < 5%

R304.3.2

Compliance	Description	Data	Compliance	Description	Data
N/A	Ramp Length LT (in)	59.0	N/A	Ramp Length RT (in)	51.5
Yes	Ramp Width LT (in)	59.0	Yes	Ramp Width RT (in)	60.0
No	Ramp Slope LT (%)	9.0	Yes	Ramp Slope RT (%)	3.0
Yes	Ramp XSlope LT (%)	0.2	Yes	Ramp XSlope RT (%)	0.9
N/A	Landing Length (in)	N/A	N/A	DWS Provided?	N/A
N/A	Landing Width (in)	N/A	N/A	DWS Contrast?	N/A
N/A	Landing Slope (%)	N/A	N/A	DWS Length (in)	N/A
N/A	Landing X Slope (%)	N/A	N/A	DWS Full Width?	N/A
N/A	Landing Curb? (Y/N)	N/A	N/A	DWS Offset (in)	N/A
N/A	Shared Landing?	N/A			
N/A	Gutter Ponding?	N/A	N/A	Gutter Slope (%)	N/A
N/A	Gutter Lip Ht (in)	N/A	N/A	Gutter X Slope (%)	N/A
N/A	Painted X Walk1?	No	N/A	Painted X Walk2?	N/A
	X Walk 1 Direction	To NW		X Walk 2 Direction	N/A
N/A	X Walk 1 Width (in)	N/A	N/A	X Walk 2 Width (in)	N/A
	X Walk 1 Slope (%)	2.1		X Walk 2 Slope (%)	N/A
	X Walk 1 X Slope (%)	0.4		X Walk 2 X Slope (%)	N/A
N/A	Ramp inside XWalk1?	N/A	N/A	Ramp inside XWalk2?	N/A

Remove & Replace Entire Ramp.
