# Access Compliance Report

## Public Rights-of-Way

### (Curb Ramps)

Intersection ID: N/A	Main Street: SUMMERFIELD RIDGE LN	Cross Street: SUMMERGROVE CT	Location: SW
ADA ID: 7FC4001B689B	Ramp Type: PerpDiag	Initial Pass/Fail: Pass	Overall Compliance: No
Codes/Mitigation Info/Possible Solution			Severity Score: 15
			Field Measurements/Component Compliance

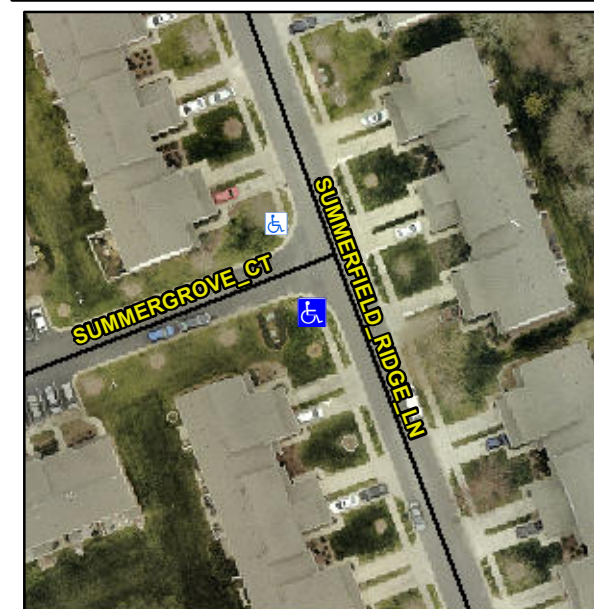
**Not Found, R304.2.2-Perp, R304.3.2-Para, R304.5.3, R305.1.4, R305.2, R302.7.2, R304.5.4**

Compliance	Description	Data	Compliance	Description	Data
N/A	Ramp Length (in)	47.0	Yes	Ramp Slope (%)	7.8
Yes	Ramp Width (in)	48.0	Yes	Ramp XSlope (%)	1.4
N/A	Flare Type LT	Sloped	N/A	Flare Type RT	N/A
N/A	Flare Slope LT (%)	7.6	N/A	Flare Slope RT (%)	4.4
N/A	Flare Traversable LT?	No	N/A	Flare Traversable RT?	No
Yes	Landing Length (in)	48.0	Yes	DWS Provided?	Yes
Yes	Landing Width (in)	60.0	Yes	DWS Contrast?	Yes
No	Landing Slope (%)	2.3	Yes	DWS Length (in)	24.0
No	Landing X Slope (%)	2.8	No	DWS Full Width?	No
N/A	Landing Curb? (Y/N)	No	No	DWS Offset (in)	8.0
N/A	Shared Landing?	No			
Yes	Gutter Ponding?	No	No	Gutter Slope (%)	6.5
No	Gutter Lip Ht (in)	0.5	Yes	Gutter X Slope (%)	1.1
N/A	Painted X Walk1?	No	N/A	Painted X Walk2?	No
	X Walk 1 Direction	To E		X Walk 2 Direction	To N
N/A	X Walk 1 Width (in)	N/A	N/A	X Walk 2 Width (in)	N/A
	X Walk 1 Slope (%)	2.1		X Walk 2 Slope (%)	3.5
	X Walk 1 X Slope (%)	2.8		X Walk 2 X Slope (%)	0.7

N/A	Ramp inside XWalk1?	N/A	N/A	Ramp inside XWalk2?	N/A
	Road Slope (%)	0.0	N/A	Clear Space?	Yes
	Road X Slope (%)	4.9	N/A	Clear Space to XWalk (in)	N/A
Yes	Any Obstructions?	No	Yes	Storm Grate/Utility Hazard?	No
	Obstruction Type			Storm Grate/Utility Type	
		N/A			N/A
			Yes	Surface Condition? (G/P)	Good

**Remove & Replace Curb Ramp With Two New Directional Ramps or Equivalent. Remove & Replace Gutter.**
