# Access Compliance Report

## Public Rights-of-Way

### (Curb Ramps)

Intersection ID: 10527	Main Street: PARKWAY_AV	Cross Street: TUCKASEEGEE_RD	Location: SW
ADA ID: 7FDBA6298C9D	Ramp Type: Directional1	Initial Pass/Fail: Fail	Overall Compliance: No
Severity Score: 10			
Codes/Mitigation Info/Possible Solution		Field Measurements/Component Compliance

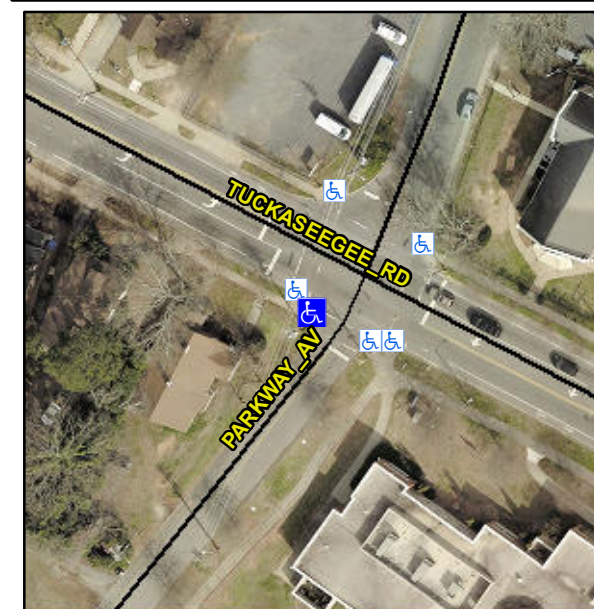
Compliance	Description	Data	Compliance	Description	Data
N/A	Ramp Length (in)	70.0	N/A	Grade Break?	N/A
No	Ramp Width (in)	47.5	N/A	Grade Break Slope (%)	0.0
Yes	Ramp Slope (%)	7.1	N/A	Grade Break XSlope (%)	0.0
No	Ramp XSlope (%)	3.3			
N/A	Flare Type LT	N/A	N/A	Flare Type RT	N/A
N/A	Flare Slope LT (%)	N/A	N/A	Flare Slope RT (%)	0.0
N/A	Flare Traversable LT?	N/A	N/A	Flare Traversable RT?	N/A
N/A	Landing Length (in)	0.0	N/A	DWS Provided?	N/A
N/A	Landing Width (in)	0.0	N/A	DWS Contrast?	N/A
N/A	Landing Slope (%)	0.0	N/A	DWS Length (in)	N/A
N/A	Landing X Slope (%)	0.0	N/A	DWS Full Width?	N/A
N/A	Landing Curb? (Y/N)	N/A	N/A	DWS Offset LT (in)	N/A
N/A	Shared Landing?	N/A	N/A	DWS Offset RT (in)	N/A
N/A	Gutter Ponding?	0.0	N/A	Gutter Slope (%)	N/A
N/A	Gutter Lip Ht (in)	0.0	N/A	Gutter X Slope (%)	N/A
N/A	Painted X Walk1?	Yes		Road Slope (%)	1.1
	X Walk 1 Direction	To E		Road X Slope (%)	0.1
	X Walk 1 Width (in)	111.0		Clear Space?	N/A

X Walk 1 Slope (%)	1.1	N/A	Clear Space to XWalk (in)	N/A
	X Walk 1 X Slope (%)	0.1	N/A	Storm Grate/Utility Hazard?	N/A
N/A	Ramp inside XWalk1?	Yes		Storm Grate/Utility Type	
N/A	Any Obstructions?	N/A			N/A
	Obstruction Type		Yes	Surface Condition? (G/P)	Good
			N/A	Curb Slope (%)	6.9

**Remove & Replace Entire Ramp.**

**R304.5.1, R304.5.3**

\$ 1600.00
