Intersection ID: 10033966		Main Street: PARK_RD		Cross Street: N/A		Location:		SW													
ADA ID: 7FDF46BDC5A0		Ramp Type: ParaDiag		Initial Pass/Fail: Fail		Overall Compliance: No		Severity Score: 26.25													
Codes/Mitigation Info/Possible Solution				Field Measurements/Component Compliance

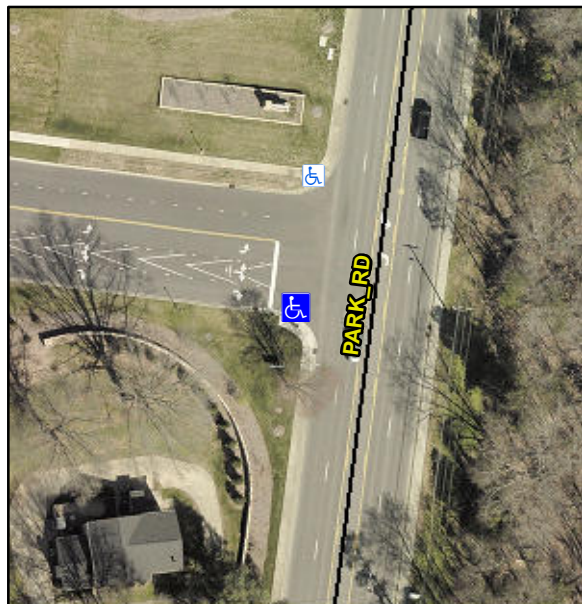
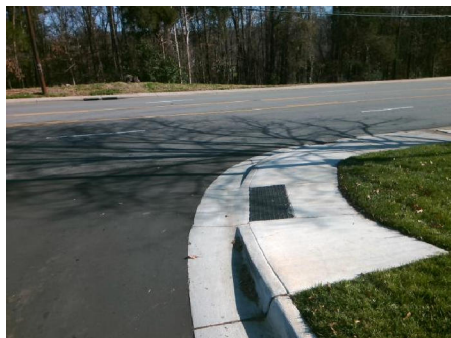
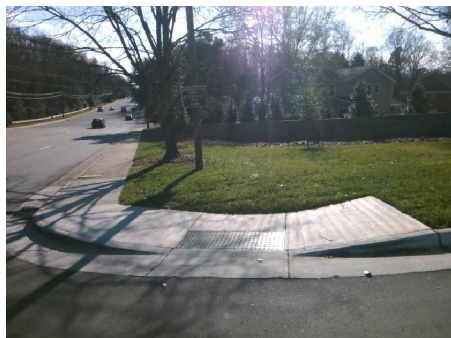
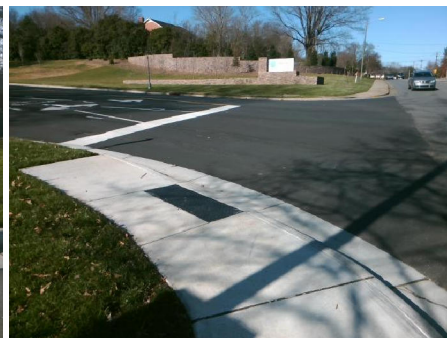
Possible Solutions:		Compliance		Description		Data		Compliance		Description		Data							
		Remove & Replace Curb Ramp With Two New Directional Ramps or Equivalent.		N/A		Ramp Length LT (in)		64.0		N/A		Ramp Length RT (in)		60.0							
				Yes		Ramp Width LT (in)		60.0		Yes		Ramp Width RT (in)		60.0							
				Yes		Ramp Slope LT (%)		2.9		No		Ramp Slope RT (%)		19.2							
				No		Ramp XSlope LT (%)		2.8		No		Ramp XSlope RT (%)		2.6							
				N/A		Landing Length (in)		N/A		N/A		DWS Provided?		N/A							
				N/A		Landing Width (in)		N/A		N/A		DWS Contrast?		N/A							
				N/A		Landing Slope (%)		N/A		N/A		DWS Length (in)		N/A

N/A		Landing X Slope (%)		N/A		N/A		DWS Full Width?		N/A							
				N/A		Landing Curb? (Y/N)		N/A		N/A		DWS Offset (in)		N/A							
<p>Surveyor Notes:</p> <p>LT RP < 5%</p> <p>PROW/ADA:</p> <p>R304.5.3, R304.3.2</p>				N/A		Shared Landing?		N/A				N/A		Gutter Slope (%)		N/A					
				N/A		Gutter Ponding?		N/A		N/A		Gutter X Slope (%)		N/A		N/A		Gutter Slope (%)		N/A	
				N/A		Gutter Lip Ht (in)		N/A		N/A		Gutter X Slope (%)		N/A		N/A		Gutter X Slope (%)		N/A	
				N/A		Painted X Walk1?		No		N/A		Painted X Walk2?		No		N/A		Painted X Walk2?		No	
						X Walk 1 Direction		To E				X Walk 2 Direction		To N				X Walk 2 Direction		To N	
				N/A		X Walk 1 Width (in)		N/A		N/A		X Walk 2 Width (in)		N/A				X Walk 2 Width (in)		N/A	
						X Walk 1 Slope (%)		4.6				X Walk 2 Slope (%)		4.9				X Walk 2 Slope (%)		4.9	
						X Walk 1 X Slope (%)		7.7				X Walk 2 X Slope (%)		5.5				X Walk 2 X Slope (%)		5.5	
				N/A		Ramp inside XWalk1?		N/A		N/A		Ramp inside XWalk2?		N/A				Ramp inside XWalk2?		N/A
