## Access Compliance Report Public Rights-of-Way (Curb Ramps)

Intersection ID: 43844	Main Street: CURRIER_RD			Cross	Street:	DELUCA_DR	Location:	SE			
ADA ID: 7FE06030E1C6	Ramp Type: Perp			Initial	Pass/Fa	ail: Fail Overall C	o Severity Score:	22.5			
Codes/Mitigation Info/Possible Solution					Field Measurements/Component Compliance						
	1	Possible Solutions:			Compliance Description Data			Compliance Description		Data	
This		Remove & Replace Enti	ire Ram	p.	N/A	Ramp Length (in)	48.0	No	Ramp Slope (%)	8.8

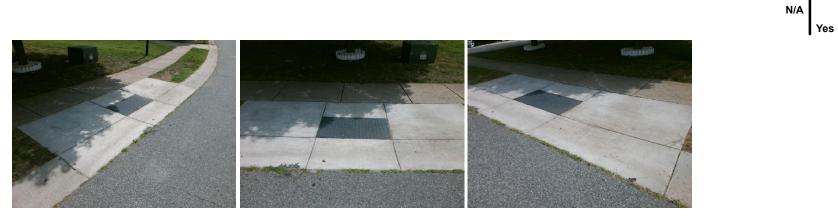
•		•	No	Ramp Width (in)	47.5	No	Ramp XSlope (%)	3.7	
					N/A	Flare Type LT	N/A	N/A	Flare Type RT	N/A	
					N/A	Flare Slope LT (%)	N/A	N/A	Flare Slope RT (%)	N/A	
	Sur A				N/A	Flare Traversable LT?	N/A	N/A	Flare Traversable RT?	N/A	
CURREN 68					N/A	Landing Length (in)	N/A	N/A	DWS Provided?	N/A	
ALLOB ST	V S	Surveyor Notes:			N/A	Landing Width (in)	N/A	N/A	DWS Contrast?	N/A	
		N/A			N/A	Landing Slope (%)	N/A	N/A	DWS Length (in)	N/A
