Access Compliance Report

Public Rights-of-Way

(Curb Ramps)

Intersection ID: 13932	Main Street: LORNA_ST	Cross Street: COMMONWEALTH_AV	Location: S
ADA ID: 7FE6AF13BD8B	Ramp Type: Perp	Initial Pass/Fail: Fail	Overall Compliance: No
Codes/Mitigation Info/Possible Solution		Field Measurements/Component Compliance

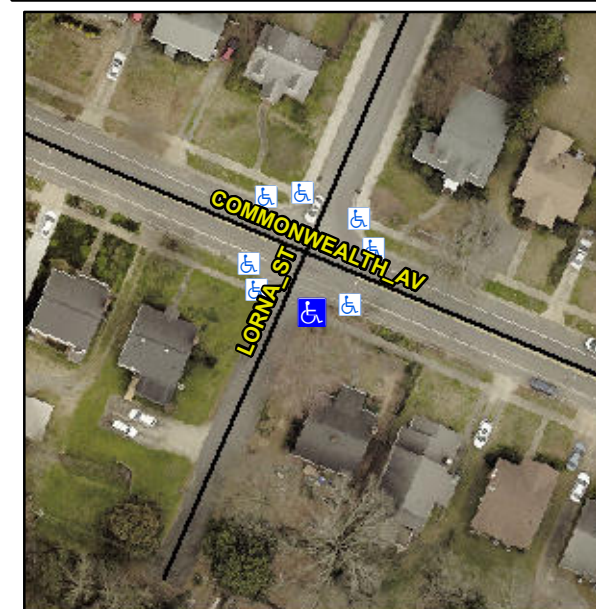
Not Found, R304.2.2, R304.5.3

Compliance	Description	Data	Compliance	Description	Data
N/A	Ramp Length (in)	46.5	No	Ramp Slope (%)	11.0
Yes	Ramp Width (in)	48.0	No	Ramp XSlope (%)	5.0
N/A	Flare Type LT	N/A	N/A	Flare Type RT	N/A
N/A	Flare Slope LT (%)	N/A	N/A	Flare Slope RT (%)	N/A
N/A	Flare Traversable LT?	N/A	N/A	Flare Traversable RT?	N/A
N/A	Landing Length (in)	N/A	N/A	DWS Provided?	N/A
N/A	Landing Width (in)	N/A	N/A	DWS Contrast?	N/A
N/A	Landing Slope (%)	N/A	N/A	DWS Length (in)	N/A
N/A	Landing X Slope (%)	N/A	N/A	DWS Full Width?	N/A
N/A	Landing Curb? (Y/N)	N/A	N/A	DWS Offset (in)	N/A
N/A	Shared Landing?	N/A			
N/A	Gutter Ponding?	N/A	N/A	Gutter Slope (%)	N/A
N/A	Gutter Lip Ht (in)	N/A	N/A	Gutter X Slope (%)	N/A
N/A	Painted X Walk1?	No	N/A	Painted X Walk2?	N/A
	X Walk 1 Direction	To NW		X Walk 2 Direction	N/A
N/A	X Walk 1 Width (in)	N/A	N/A	X Walk 2 Width (in)	N/A
	X Walk 1 Slope (%)	6.7		X Walk 2 Slope (%)	N/A
	X Walk 1 X Slope (%)	4.7		X Walk 2 X Slope (%)	N/A

N/A	Ramp inside XWalk1?	N/A	N/A	Ramp inside XWalk2?	N/A
	Road Slope (%)	N/A	N/A	Clear Space?	N/A
	Road X Slope (%)	N/A	N/A	Clear Space to XWalk (in)	N/A
N/A	Any Obstructions?	N/A	N/A	Storm Grate/Utility Hazard?	N/A
	Obstruction Type			Storm Grate/Utility Type	
		N/A			N/A
			Yes	Surface Condition? (G/P)	Good

Possible Solutions:

Remove & Replace Entire Ramp.
