# Access Compliance Report

## Public Rights-of-Way

| Intersection ID: 3033 | Main Street: DEARMON_RD | Cross Street: BENFIELD_RD | Location: | N |
| ADA ID: 7FEB98CA6E8A | Ramp Type: BlendTrans1 | Initial Pass/Fail: Pass | Overall Compliance: No | Severity Score: 0 |

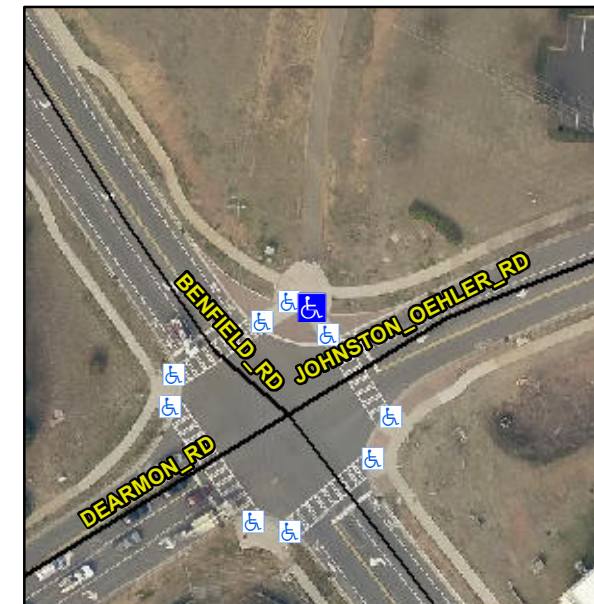
**Not Found, R305.2, R304.5.4, R304.5.3**

| Compliance | Description | Data | Compliance | Description | Data |
|---|---|---|---|---|---|
| N/A | Landing Curb? (Y/N) | No | No | DWS Offset (in) | 3.0 |
| Yes | Gutter Lip Ht (in) | 0.0 | No | Gutter X Slope (%) | N/A |
| | | | No | Curb Slope (%) | 15.1 |

**Remove & Replace Curb Ramp With Two New Directional Ramps or Equivalent. Remove & Replace Gutter.**
