Access Compliance Report Public Rights-of-Way (Curb Ramps)

Main Street: BELL'S MILL DR Cross Street: N/A Location: Ε Intersection ID: 1000791 **ADA ID: 7FECD416629C** Initial Pass/Fail: Fail **Overall Compliance: No** 25 Ramp Type: BlendTrans2 **Severity Score:**

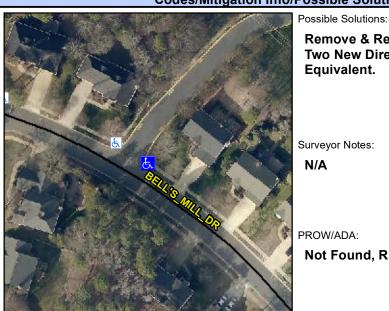
55.0 No

N/A	Landing X Slope (%)	N/A	N/A	DWS Full Width?
		N/A	Landing Curb? (Y/N)	N/A	N/A	DWS Offset (in)
		N/A	Shared Landing?	N/A		
PROW/ADA:		N/A	Gutter Ponding?	N/A	N/A	Gutter Slope (%)
Not Found, R304.5.3		N/A	Gutter Lip Ht (in)	N/A	N/A	Gutter X Slope (%)
· ·		N/A	Painted X Walk1?	No	N/A	Painted X Walk2?
			X Walk 1 Direction	To NW		X Walk 2 Direction
			X Walk 1 Width (in)	N/A		X Walk 2 Width (in)
			X Walk 1 Slope (%)	2.8		X Walk 2 Slope (%)
			X Walk 1 X Slope (%)	2.7		X Walk 2 X Slope (%)
		N/A	Ramp inside XWalk1?	N/A	N/A	Ramp inside XWalk2?
			Road Slope (%)	2.7		Clear Space?
			Road X Slope (%)	2.8	N/A	Clear Space to XWalk (in)
		N/A	Any Obstructions?	N/A	N/A	Storm Grate/Utility Hazard?
Total Cost:	\$ 3200.00		Obstruction Type			Storm Grate/Utility Type
				N/A

Remove & Replace Curb Ramp With Two New Directional Ramps or Equivalent.
