# Access Compliance Report

## Public Rights-of-Way

### (Curb Ramps)

Intersection ID: 14789	Main Street: E_5TH_ST	Cross Street: EMERSON_AV	Location: SW
ADA ID: 7FEE5E5FAB40	Ramp Type: Directional1	Initial Pass/Fail: Fail	Overall Compliance: No
		Severity Score: 10

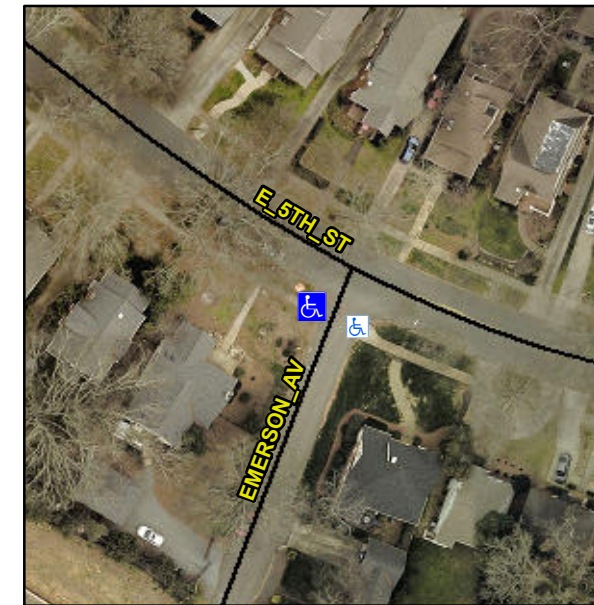
Compliance	Description	Data	Compliance	Description	Data
N/A	Ramp Length (in)	120.0	N/A	Grade Break?	N/A
No	Ramp Width (in)	43.0	N/A	Grade Break Slope (%)	0.0
Yes	Ramp Slope (%)	5.2	N/A	Grade Break XSlope (%)	0.0
No	Ramp XSlope (%)	2.9			
N/A	Flare Type LT	N/A	N/A	Flare Type RT	N/A
N/A	Flare Slope LT (%)	N/A	N/A	Flare Slope RT (%)	0.0
N/A	Flare Traversable LT?	N/A	N/A	Flare Traversable RT?	N/A
N/A	Landing Length (in)	0.0	N/A	DWS Provided?	N/A
N/A	Landing Width (in)	0.0	N/A	DWS Contrast?	N/A
N/A	Landing Slope (%)	0.0	N/A	DWS Length (in)	N/A
N/A	Landing X Slope (%)	0.0	N/A	DWS Full Width?	N/A
N/A	Landing Curb? (Y/N)	N/A	N/A	DWS Offset LT (in)	N/A
N/A	Shared Landing?	N/A	N/A	DWS Offset RT (in)	N/A
N/A	Gutter Ponding?	0.0	N/A	Gutter Slope (%)	N/A
N/A	Gutter Lip Ht (in)	0.0	N/A	Gutter X Slope (%)	N/A
N/A	Painted X Walk1?	No		Road Slope (%)	5.5
	X Walk 1 Direction	To SE		Road X Slope (%)	2.8
	X Walk 1 Width (in)	N/A		Clear Space?	N/A

X Walk 1 Slope (%)	5.5	N/A	Clear Space to XWalk (in)	N/A
	X Walk 1 X Slope (%)	2.8	N/A	Storm Grate/Utility Hazard?	N/A
N/A	Ramp inside XWalk1?	N/A		Storm Grate/Utility Type	
N/A	Any Obstructions?	N/A			N/A
	Obstruction Type		Yes	Surface Condition? (G/P)	Good
			N/A	Curb Slope (%)	8.6

Possible Solutions:

**Remove & Replace Entire Ramp.**

**R304.5.1, R304.5.3**
