## **Access Compliance Report Public Rights-of-Way** (Curb Ramps)

Intersection ID: 49450 Main Street: MARICOPA RD **Cross Street: ALVARADO WY** Location: NE **Overall Compliance: No Severity Score:** ADA ID: 7FF008B5EDB8 Ramp Type: Perp Initial Pass/Fail: Fail 8.75

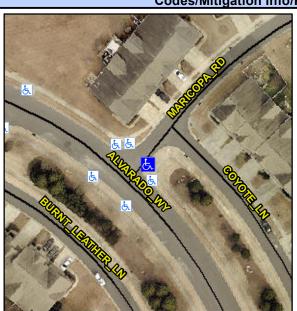
MARICOPA RD Street 1 Name Stop Condition-Street 2 StopSign N/A Street 2 Name Stop Condition-Street 1 N/A Possible Solutions: Remove & Replace Entire Ramp. Surveyor Notes: N/A PROW/ADA: R304.5.1

N/A N/A N/A N/A N/A Total Cost: 1850.00
