# Access Compliance Report

## Public Rights-of-Way

### (Curb Ramps)

Intersection ID: 10031916	Main Street: MOCK_ORANGE_DR	Cross Street: N/A	Location:	N
ADA ID: 800643C20147	Ramp Type: Perp	Initial Pass/Fail: Fail	Overall Compliance: No	Severity Score: 25
Codes/Mitigation Info/Possible Solution		Field Measurements/Component Compliance

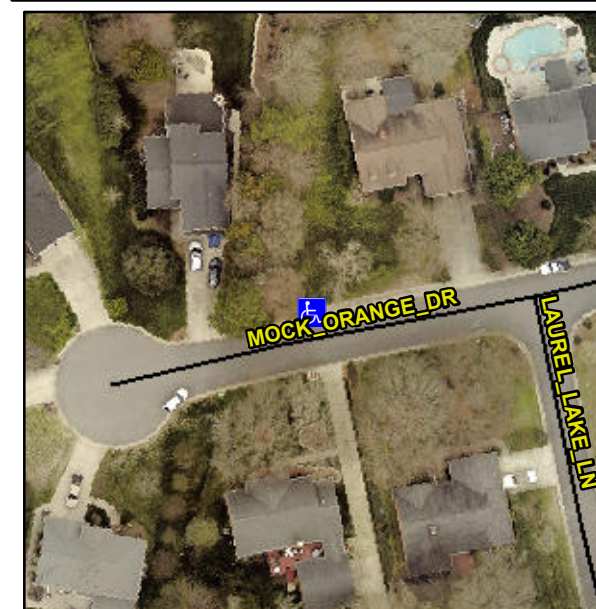
Compliance	Description	Data	Compliance	Description	Data
N/A	Ramp Length (in)	47.0	Yes	Ramp Slope (%)	6.5
Yes	Ramp Width (in)	48.0	No	Ramp XSlope (%)	7.0
N/A	Flare Type LT	N/A	N/A	Flare Type RT	N/A
N/A	Flare Slope LT (%)	N/A	N/A	Flare Slope RT (%)	N/A
N/A	Flare Traversable LT?	N/A	N/A	Flare Traversable RT?	N/A
N/A	Landing Length (in)	N/A	N/A	DWS Provided?	N/A
N/A	Landing Width (in)	N/A	N/A	DWS Contrast?	N/A
N/A	Landing Slope (%)	N/A	N/A	DWS Length (in)	N/A
N/A	Landing X Slope (%)	N/A	N/A	DWS Full Width?	N/A
N/A	Landing Curb? (Y/N)	N/A	N/A	DWS Offset (in)	N/A
N/A	Shared Landing?	N/A			
N/A	Gutter Ponding?	N/A	N/A	Gutter Slope (%)	N/A
N/A	Gutter Lip Ht (in)	N/A	N/A	Gutter X Slope (%)	N/A
N/A	Painted X Walk1?	No	N/A	Painted X Walk2?	N/A
	X Walk 1 Direction	To S		X Walk 2 Direction	N/A
N/A	X Walk 1 Width (in)	N/A	N/A	X Walk 2 Width (in)	N/A
	X Walk 1 Slope (%)	4.1		X Walk 2 Slope (%)	N/A
	X Walk 1 X Slope (%)	7.8		X Walk 2 X Slope (%)	N/A

N/A	Ramp inside XWalk1?	N/A	N/A	Ramp inside XWalk2?	N/A
	Road Slope (%)	N/A	N/A	Clear Space?	N/A
	Road X Slope (%)	N/A	N/A	Clear Space to XWalk (in)	N/A
N/A	Any Obstructions?	N/A	N/A	Storm Grate/Utility Hazard?	N/A
	Obstruction Type			Storm Grate/Utility Type	
		N/A			N/A
			Yes	Surface Condition? (G/P)	Good

Possible Solutions:

**Remove & Replace Entire Ramp.**

**R304.5.3**

Total Cost: \$ 1850.00
