## **Access Compliance Report Public Rights-of-Way** (Curb Ramps)

Intersection ID: 31837 Main Street: VICKSBURG RD **Cross Street: WILLS\_WY** Location: NE **Severity Score: ADA ID: 8018BBFBC038** Ramp Type: Perp Initial Pass/Fail: Fail **Overall Compliance: No** 50

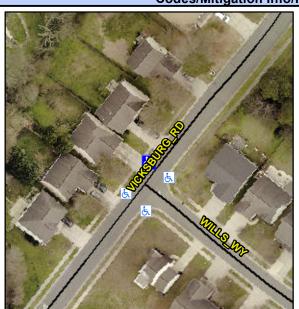
Field Measurements/Component Compliance						
Compliance Description		Data	Comp	liance	Description	Data
N/A	Ramp Length (in)	47.0	No	Ramp	Slope (%)	12.1
Yes	Ramp Width (in)	51.0	No	Ramp	XSlope (%)	10.0
N/A	Flare Type LT	N/A	N/A	I/A Flare Type RT		N/A
N/A	Flare Slope LT (%)	N/A	N/A	I/A Flare Slope RT (%)		N/A
N/A	Flare Traversable LT?	N/A	N/A	Flare	Traversable RT?	N/A
N/A	Landing Length (in)	N/A	N/A	DWS	Provided?	N/A
N/A	Landing Width (in)	N/A	N/A	DWS	Contrast?	N/A
N/A	Landing Slope (%)	N/A	N/A	DWS	Length (in)	N/A
N/A	Landing X Slope (%)	N/A	N/A	DWS	Full Width?	N/A
N/A	Landing Curb? (Y/N)	N/A	N/A	DWS	Offset (in)	N/A
N/A	Shared Landing?	N/A				
N/A	Gutter Ponding?	N/A	N/A	Gutte	r Slope (%)	N/A
N/A	Gutter Lip Ht (in)	N/A	N/A	Gutte	r X Slope (%)	N/A
N/A	Painted X Walk1?	No	N/A	Paint	ed X Walk2?	N/A
	X Walk 1 Direction	To SE		X Wa	lk 2 Direction	N/A
N/A	X Walk 1 Width (in)	N/A	N/A	X Wa	lk 2 Width (in)	N/A
	X Walk 1 Slope (%)	0.1		X Wa	lk 2 Slope (%)	N/A

X Walk 1 X Slope (%)	9.1		X Wa	lk 2 X Slope (%)	N/A
N/A	Ramp inside XWalk1?	N/A	N/A	Ramp	inside XWalk2?	N/A
	Road Slope (%)	N/A	N/A	Clear	Space?	N/A
	Road X Slope (%)	N/A	N/A	Clear	Space to XWalk (in)	N/A
N/A	Any Obstructions?	N/A	N/A	Storm	n Grate/Utility Hazard?	N/A
	Obstruction Type			Storm	n Grate/Utility Type	
		N/A				N/A
			Yes	Surfa	ce Condition? (G/P)	Good
THE RESERVE	WALL SERVICE

Possible Solutions: Remove & Replace Entire Ramp. Surveyor Notes: N/A PROW/ADA: Not Found, R304.2.2, R304.5.3
