Access Compliance Report

Public Rights-of-Way

(Curb Ramps)

Intersection ID: 26100	Main Street: FAIRCHILD_LN	Cross Street: HOLLY_HILL_FARM_RD	Location: SE
ADA ID: 801DD9B9AD67	Ramp Type: PerpDiag	Initial Pass/Fail: Fail	Overall Compliance: No
Severity Score: 37.5			
Codes/Mitigation Info/Possible Solution		Field Measurements/Component Compliance

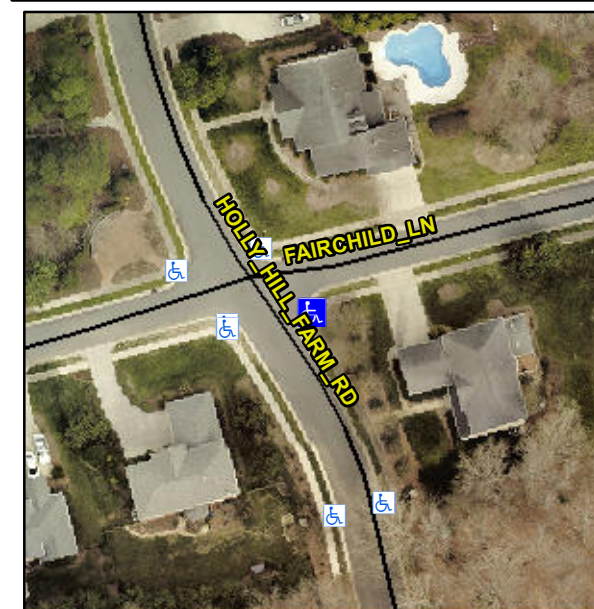
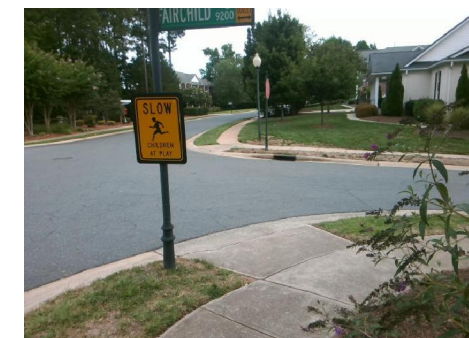
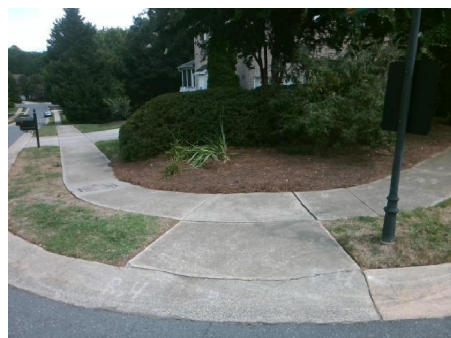
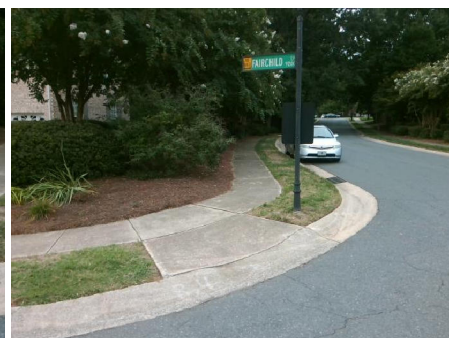
Compliance	Description	Data	Compliance	Description	Data
N/A	Ramp Length (in)	48.0	No	Ramp Slope (%)	10.1
Yes	Ramp Width (in)	49.0	No	Ramp XSlope (%)	8.1
N/A	Flare Type LT	N/A	N/A	Flare Type RT	N/A
N/A	Flare Slope LT (%)	N/A	N/A	Flare Slope RT (%)	N/A
N/A	Flare Traversable LT?	N/A	N/A	Flare Traversable RT?	N/A
N/A	Landing Length (in)	N/A	N/A	DWS Provided?	N/A
N/A	Landing Width (in)	N/A	N/A	DWS Contrast?	N/A
N/A	Landing Slope (%)	N/A	N/A	DWS Length (in)	N/A
N/A	Landing X Slope (%)	N/A	N/A	DWS Full Width?	N/A
N/A	Landing Curb? (Y/N)	N/A	N/A	DWS Offset (in)	N/A
N/A	Shared Landing?	N/A			
N/A	Gutter Ponding?	N/A	N/A	Gutter Slope (%)	N/A
N/A	Gutter Lip Ht (in)	N/A	N/A	Gutter X Slope (%)	N/A
N/A	Painted X Walk1?	No	N/A	Painted X Walk2?	No
	X Walk 1 Direction	To NW		X Walk 2 Direction	To W
N/A	X Walk 1 Width (in)	N/A	N/A	X Walk 2 Width (in)	N/A
	X Walk 1 Slope (%)	0.4		X Walk 2 Slope (%)	6.0
	X Walk 1 X Slope (%)	6.1		X Walk 2 X Slope (%)	1.1

N/A	Ramp inside XWalk1?	N/A	N/A	Ramp inside XWalk2?	N/A
	Road Slope (%)	3.6	N/A	Clear Space?	N/A
	Road X Slope (%)	4.6	N/A	Clear Space to XWalk (in)	N/A
N/A	Any Obstructions?	N/A	N/A	Storm Grate/Utility Hazard?	N/A
	Obstruction Type			Storm Grate/Utility Type	
		N/A			N/A
			Yes	Surface Condition? (G/P)	Good

Remove & Replace Curb Ramp With Two New Directional Ramps or Equivalent.
