# Access Compliance Report

## Public Rights-of-Way

### (Curb Ramps)

| Intersection ID: 23151 | Main Street: LAUREL_POINTE_WY | Cross Street: MOSS_RD | Location: NW |

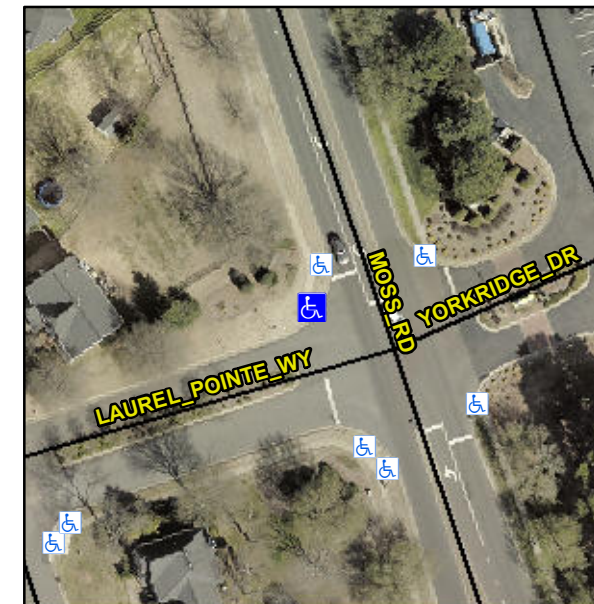
| ADA ID: 80257871F1C9 | Ramp Type: Perp | Initial Pass/Fail: Fail | Overall Compliance: No<br>Severity Score: 13.75 |

**Not Found, R304.2.2, R304.5.3**

| Compliance | Description | Data | Compliance | Description | Data |
|---|---|---|---|---|---|
| N/A | Ramp Length (in) | 123.0 | No | Ramp Slope (%) | 9.4 |
| Yes | Ramp Width (in) | 48.0 | No | Ramp XSlope (%) | 4.8 |

**Remove & Replace Entire Ramp.**

Total Cost: \$ 1850.00
