Access Compliance Report

Public Rights-of-Way (Curb Ramps)

Intersection ID: 17405	Main Street: RIDGEWOOD_AV	Cross Street: WESTFIELD_RD	Location: SE
ADA ID: 80295C34946E	Ramp Type: PerpDiag	Initial Pass/Fail: Fail	Overall Compliance: No
Severity Score: 8.75			
Codes/Mitigation Info/Possible Solution		Field Measurements/Component Compliance

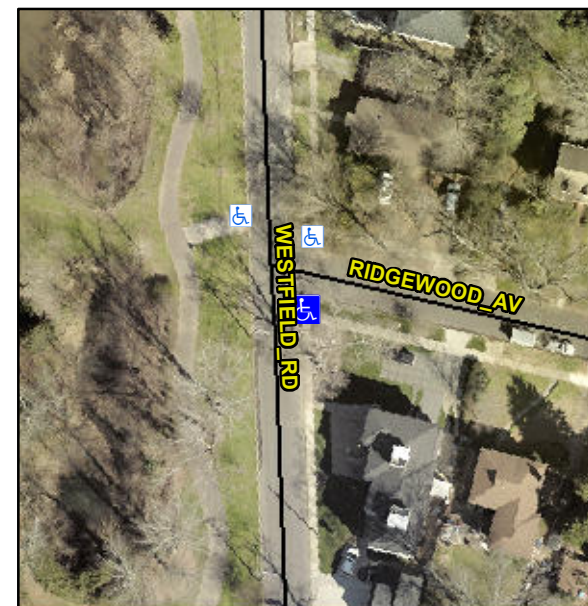
Not Found, R304.5.1

Compliance	Description	Data	Compliance	Description	Data
N/A	Ramp Length (in)	64.0	Yes	Ramp Slope (%)	5.3
No	Ramp Width (in)	40.0	Yes	Ramp XSlope (%)	1.2
N/A	Flare Type LT	N/A	N/A	Flare Type RT	N/A
N/A	Flare Slope LT (%)	N/A	N/A	Flare Slope RT (%)	N/A
N/A	Flare Traversable LT?	N/A	N/A	Flare Traversable RT?	N/A
N/A	Landing Length (in)	N/A	N/A	DWS Provided?	N/A
N/A	Landing Width (in)	N/A	N/A	DWS Contrast?	N/A
N/A	Landing Slope (%)	N/A	N/A	DWS Length (in)	N/A
N/A	Landing X Slope (%)	N/A	N/A	DWS Full Width?	N/A
N/A	Landing Curb? (Y/N)	N/A	N/A	DWS Offset (in)	N/A
N/A	Shared Landing?	N/A			
N/A	Gutter Ponding?	N/A	N/A	Gutter Slope (%)	N/A
N/A	Gutter Lip Ht (in)	N/A	N/A	Gutter X Slope (%)	N/A
N/A	Painted X Walk1?	No	N/A	Painted X Walk2?	No
	X Walk 1 Direction	To N		X Walk 2 Direction	To W
N/A	X Walk 1 Width (in)	N/A	N/A	X Walk 2 Width (in)	N/A
	X Walk 1 Slope (%)	3.8		X Walk 2 Slope (%)	2.3
	X Walk 1 X Slope (%)	2.2		X Walk 2 X Slope (%)	1.7

N/A	Ramp inside XWalk1?	N/A	N/A	Ramp inside XWalk2?	N/A
	Road Slope (%)	3.2	N/A	Clear Space?	N/A
	Road X Slope (%)	1.2	N/A	Clear Space to XWalk (in)	N/A
N/A	Any Obstructions?	N/A	N/A	Storm Grate/Utility Hazard?	N/A
	Obstruction Type			Storm Grate/Utility Type	
		N/A			N/A
		Yes		Surface Condition? (G/P)	Good

Remove & Replace Curb Ramp With Two New Directional Ramps or Equivalent.
