Access Compliance Report Public Rights-of-Way (Curb Ramps)

Intersection ID: 52288Main Street:STEELE_CREEK_RDCross Street:DIXIE_RIVER_RDLocation:SWADA ID: 8032A6B341BERamp Type:ParaInitial Pass/Fail:FailOverall Compliance:NoSeverity Score:1.25

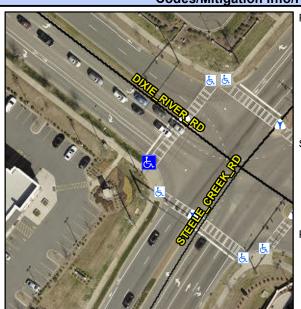
Comp	liance Description	Data	omponent Compliance Compliance Description			Data
N/A	Ramp Length LT (in)	57.0	N/A		Length RT (in)	65.0
Yes	Ramp Width LT (in)	90.0	Yes		Width RT (in)	93.0
Yes	Ramp Slope LT (%)	5.8	Yes	•	Slope RT (%)	8.2
No	Ramp XSlope LT (%)	2.2	No	•	XSlope RT (%)	2.2
N/A	Landing Length (in)	N/A	N/A	•	Provided?	N/A
N/A	Landing Width (in)	N/A	N/A		Contrast?	N/A
N/A	Landing Slope (%)	N/A	N/A		Length (in)	N/A
N/A	Landing X Slope (%)	N/A	N/A		Full Width?	N/A
N/A	Landing X Slope (%) Landing Curb? (Y/N)	N/A	N/A		Offset (in)	N/A
N/A	Shared Landing?	N/A N/A	IN/A	DWS	Oliset (III)	N/A
N/A	ŭ	N/A N/A	N/A	Cutto	r Clana (0/)	N/A
	Gutter Ponding?				r Slope (%)	
N/A	Gutter Lip Ht (in)	N/A	N/A		r X Slope (%)	N/A
N/A	Painted X Walk1?	Yes	N/A		ed X Walk2?	N/A
	X Walk 1 Direction	To NE			k 2 Direction	N/A
N/A	X Walk 1 Width (in)	111.0	N/A		k 2 Width (in)	N/A
	X Walk 1 Slope (%)	2.2			k 2 Slope (%)	N/A
	X Walk 1 X Slope (%)	0.1		X Wal	k 2 X Slope (%)	N/A

N/A	Ramp inside XWalk1?	Yes	N/A	Ramp	inside XWalk2?	N/A
	Road Slope (%)	N/A	N/A	Clear	Space?	N/A
	Road X Slope (%)	N/A	N/A	Clear	Space to XWalk (in)	N/A
N/A	Any Obstructions?	N/A	N/A	Storm	Grate/Utility Hazard?	N/A
	Obstruction Type			Storm	Grate/Utility Type	
		N/A				N/A
			Yes	Surfac	ce Condition? (G/P)	Good
			N/A	Curb	Slope (%)	6.0

Possible Solutions:						
Remove & Replace Entire Ramp.						
Surveyor Notes:						
N/A						
PDOW/ADA						
R304.5.3						
PROW/ADA: R304.5.3

Total Cost: \$ 1600.00
