Access Compliance Report

Public Rights-of-Way

(Curb Ramps)

Intersection ID: 53357	Main Street: SEEGARS_PL	Cross Street: HELTON_WY	Location: NE
ADA ID: 8036F236D857	Ramp Type: Perp	Initial Pass/Fail: Fail	Overall Compliance: No
Severity Score: 8.75			
Codes/Mitigation Info/Possible Solution		Field Measurements/Component Compliance

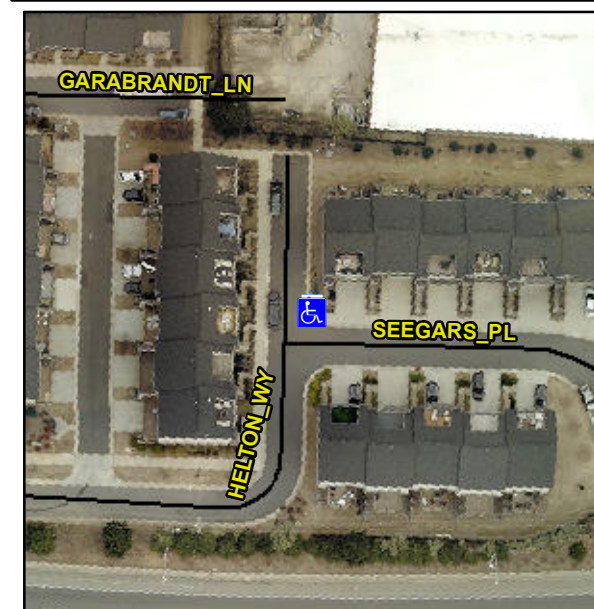
Compliance	Description	Data	Compliance	Description	Data
N/A	Ramp Length (in)	44.0	Yes	Ramp Slope (%)	7.9
No	Ramp Width (in)	46.0	Yes	Ramp XSlope (%)	1.6
N/A	Flare Type LT	N/A	N/A	Flare Type RT	N/A
N/A	Flare Slope LT (%)	N/A	N/A	Flare Slope RT (%)	N/A
N/A	Flare Traversable LT?	N/A	N/A	Flare Traversable RT?	N/A
N/A	Landing Length (in)	N/A	N/A	DWS Provided?	N/A
N/A	Landing Width (in)	N/A	N/A	DWS Contrast?	N/A
N/A	Landing Slope (%)	N/A	N/A	DWS Length (in)	N/A
N/A	Landing X Slope (%)	N/A	N/A	DWS Full Width?	N/A
N/A	Landing Curb? (Y/N)	N/A	N/A	DWS Offset (in)	N/A
N/A	Shared Landing?	N/A			
N/A	Gutter Ponding?	N/A	N/A	Gutter Slope (%)	N/A
N/A	Gutter Lip Ht (in)	N/A	N/A	Gutter X Slope (%)	N/A
N/A	Painted X Walk1?	No	N/A	Painted X Walk2?	N/A
	X Walk 1 Direction	To W		X Walk 2 Direction	N/A
N/A	X Walk 1 Width (in)	N/A	N/A	X Walk 2 Width (in)	N/A
	X Walk 1 Slope (%)	3.1		X Walk 2 Slope (%)	N/A
	X Walk 1 X Slope (%)	1.3		X Walk 2 X Slope (%)	N/A

Remove & Replace Entire Ramp.

R304.5.1
