Access Compliance Report

Public Rights-of-Way

(Curb Ramps)

Intersection ID: 11920	Main Street: FREEDOM_DR	Cross Street: WOODRUFF_PL	Location: NW
ADA ID: 8038E9C66362	Ramp Type: Perp	Initial Pass/Fail: Fail	Overall Compliance: No
		Severity Score: 10

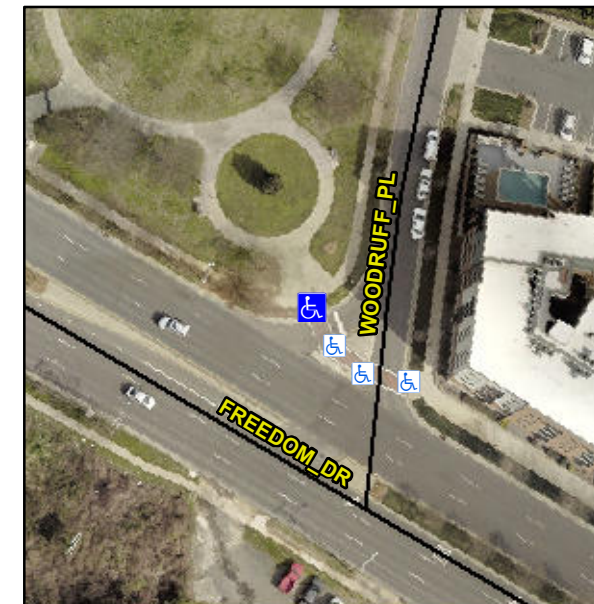
Not Found, R304.5.1, R304.5.3

Compliance	Description	Data	Compliance	Description	Data
N/A	Ramp Length (in)	71.0	Yes	Ramp Slope (%)	5.7
No	Ramp Width (in)	46.0	No	Ramp XSlope (%)	3.5
N/A	Flare Type LT	N/A	N/A	Flare Type RT	N/A
N/A	Flare Slope LT (%)	N/A	N/A	Flare Slope RT (%)	N/A
N/A	Flare Traversable LT?	N/A	N/A	Flare Traversable RT?	N/A
N/A	Landing Length (in)	N/A	N/A	DWS Provided?	N/A
N/A	Landing Width (in)	N/A	N/A	DWS Contrast?	N/A
N/A	Landing Slope (%)	N/A	N/A	DWS Length (in)	N/A
N/A	Landing X Slope (%)	N/A	N/A	DWS Full Width?	N/A
N/A	Landing Curb? (Y/N)	N/A	N/A	DWS Offset (in)	N/A
N/A	Shared Landing?	N/A			
N/A	Gutter Ponding?	N/A	N/A	Gutter Slope (%)	N/A
N/A	Gutter Lip Ht (in)	N/A	N/A	Gutter X Slope (%)	N/A
N/A	Painted X Walk1?	Yes	N/A	Painted X Walk2?	N/A
	X Walk 1 Direction	To SE		X Walk 2 Direction	N/A
N/A	X Walk 1 Width (in)	93.0	N/A	X Walk 2 Width (in)	N/A
	X Walk 1 Slope (%)	1.9		X Walk 2 Slope (%)	N/A
	X Walk 1 X Slope (%)	3.3		X Walk 2 X Slope (%)	N/A

N/A	Ramp inside XWalk1?	Yes	N/A	Ramp inside XWalk2?	N/A
	Road Slope (%)	N/A	N/A	Clear Space?	N/A
	Road X Slope (%)	N/A	N/A	Clear Space to XWalk (in)	N/A
N/A	Any Obstructions?	N/A	N/A	Storm Grate/Utility Hazard?	N/A
	Obstruction Type			Storm Grate/Utility Type	
		N/A			N/A
			Yes	Surface Condition? (G/P)	Good

Remove & Replace Entire Ramp.
