Access Compliance Report

Public Rights-of-Way

(Curb Ramps)

Intersection ID: 10033765	Main Street: OXFORD COMMONS DR	Cross Street: N/A	Location: S
ADA ID: 80417D25C3AB	Ramp Type: Perp	Initial Pass/Fail: Fail	Overall Compliance: No
Severity Score: 13.75			
Codes/Mitigation Info/Possible Solution		Field Measurements/Component Compliance

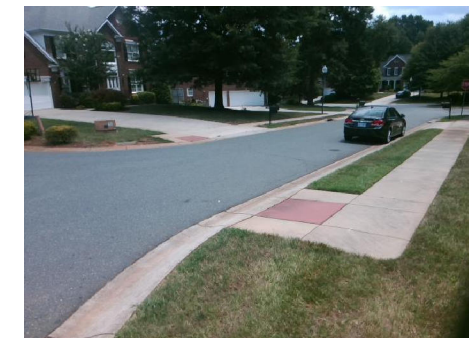
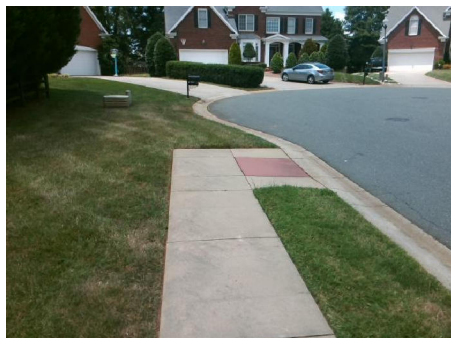
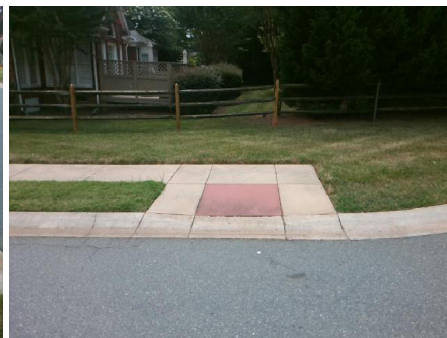
Compliance	Description	Data	Compliance	Description	Data
N/A	Ramp Length (in)	46.0	No	Ramp Slope (%)	9.3
Yes	Ramp Width (in)	48.0	Yes	Ramp XSlope (%)	3.7
N/A	Flare Type LT	N/A	N/A	Flare Type RT	N/A
N/A	Flare Slope LT (%)	N/A	N/A	Flare Slope RT (%)	N/A
N/A	Flare Traversable LT?	N/A	N/A	Flare Traversable RT?	N/A
N/A	Landing Length (in)	N/A	N/A	DWS Provided?	N/A
N/A	Landing Width (in)	N/A	N/A	DWS Contrast?	N/A
N/A	Landing Slope (%)	N/A	N/A	DWS Length (in)	N/A
N/A	Landing X Slope (%)	N/A	N/A	DWS Full Width?	N/A
N/A	Landing Curb? (Y/N)	N/A	N/A	DWS Offset (in)	N/A
N/A	Shared Landing?	N/A			
N/A	Gutter Ponding?	N/A	N/A	Gutter Slope (%)	N/A
N/A	Gutter Lip Ht (in)	N/A	N/A	Gutter X Slope (%)	N/A
N/A	Painted X Walk1?	No	N/A	Painted X Walk2?	N/A
	X Walk 1 Direction	To NE		X Walk 2 Direction	N/A
N/A	X Walk 1 Width (in)	N/A	N/A	X Walk 2 Width (in)	N/A
	X Walk 1 Slope (%)	1.1		X Walk 2 Slope (%)	N/A
	X Walk 1 X Slope (%)	6.5		X Walk 2 X Slope (%)	N/A

N/A	Ramp inside XWalk1?	N/A	N/A	Ramp inside XWalk2?	N/A
	Road Slope (%)	N/A	N/A	Clear Space?	N/A
	Road X Slope (%)	N/A	N/A	Clear Space to XWalk (in)	N/A
N/A	Any Obstructions?	N/A	N/A	Storm Grate/Utility Hazard?	N/A
	Obstruction Type			Storm Grate/Utility Type	
		N/A			N/A
			Yes	Surface Condition? (G/P)	Good

Possible Solutions:

Remove & Replace Entire Ramp.
