# Access Compliance Report

## Public Rights-of-Way

### (Curb Ramps)

Intersection ID: 28724	Main Street: NORTHWOODS_FOREST_DR	Cross Street: LAWING_SCHOOL_RD	Location:	N
ADA ID: 80425D952009	Ramp Type: Directional1	Initial Pass/Fail: Fail	Overall Compliance: No	Severity Score: 10
Codes/Mitigation Info/Possible Solution		Field Measurements/Component Compliance

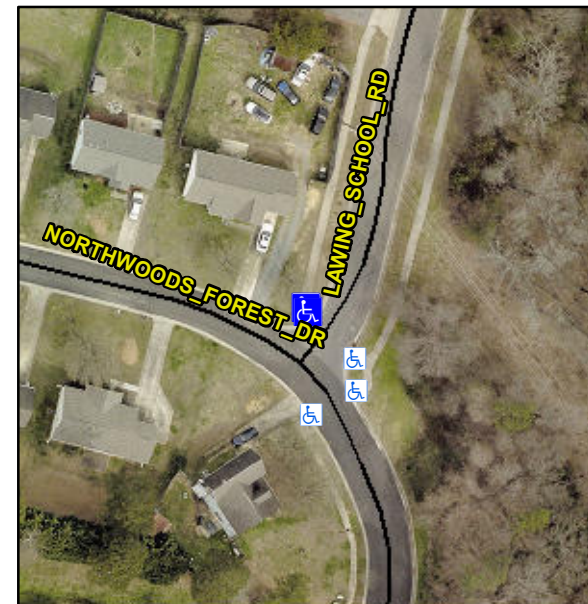
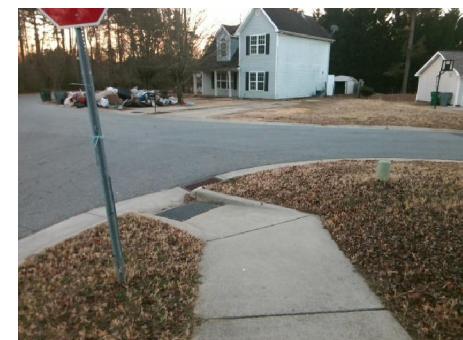
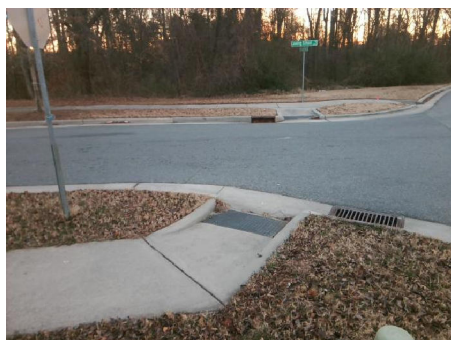
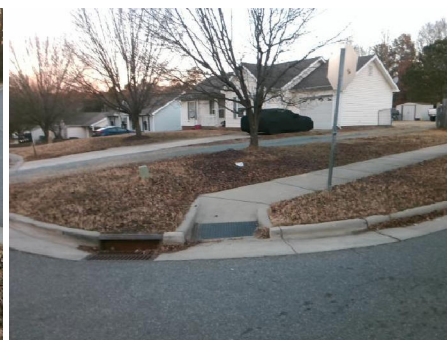
Compliance	Description	Data	Compliance	Description	Data
N/A	Ramp Length (in)	64.0	N/A	Grade Break?	N/A
No	Ramp Width (in)	42.0	N/A	Grade Break Slope (%)	0.0
Yes	Ramp Slope (%)	5.4	N/A	Grade Break XSlope (%)	0.0
No	Ramp XSlope (%)	2.3			
N/A	Flare Type LT	N/A	N/A	Flare Type RT	N/A
N/A	Flare Slope LT (%)	N/A	N/A	Flare Slope RT (%)	0.0
N/A	Flare Traversable LT?	N/A	N/A	Flare Traversable RT?	N/A
N/A	Landing Length (in)	0.0	N/A	DWS Provided?	N/A
N/A	Landing Width (in)	0.0	N/A	DWS Contrast?	N/A
N/A	Landing Slope (%)	0.0	N/A	DWS Length (in)	N/A
N/A	Landing X Slope (%)	0.0	N/A	DWS Full Width?	N/A
N/A	Landing Curb? (Y/N)	N/A	N/A	DWS Offset LT (in)	N/A
N/A	Shared Landing?	N/A	N/A	DWS Offset RT (in)	N/A
N/A	Gutter Ponding?	0.0	N/A	Gutter Slope (%)	N/A
N/A	Gutter Lip Ht (in)	0.0	N/A	Gutter X Slope (%)	N/A
N/A	Painted X Walk1?	No		Road Slope (%)	1.4
	X Walk 1 Direction	To SE		Road X Slope (%)	0.2
	X Walk 1 Width (in)	N/A		Clear Space?	N/A

X Walk 1 Slope (%)	1.4	N/A	Clear Space to XWalk (in)	N/A
	X Walk 1 X Slope (%)	0.2	N/A	Storm Grate/Utility Hazard?	N/A
N/A	Ramp inside XWalk1?	N/A		Storm Grate/Utility Type	
N/A	Any Obstructions?	N/A			N/A
	Obstruction Type		Yes	Surface Condition? (G/P)	Good
			N/A	Curb Slope (%)	1.5

**Remove & Replace Entire Ramp.**

**R304.5.1, R304.5.3**
