Access Compliance Report

Public Rights-of-Way

(Curb Ramps)

Intersection ID: 31684	Main Street: HYACINTH_CT	Cross Street: WILLIE_WORRELL_DR	Location: NW
ADA ID: 80505F6DECF9	Ramp Type: PerpDiag	Initial Pass/Fail: Fail	Overall Compliance: No
			Severity Score: 33.75

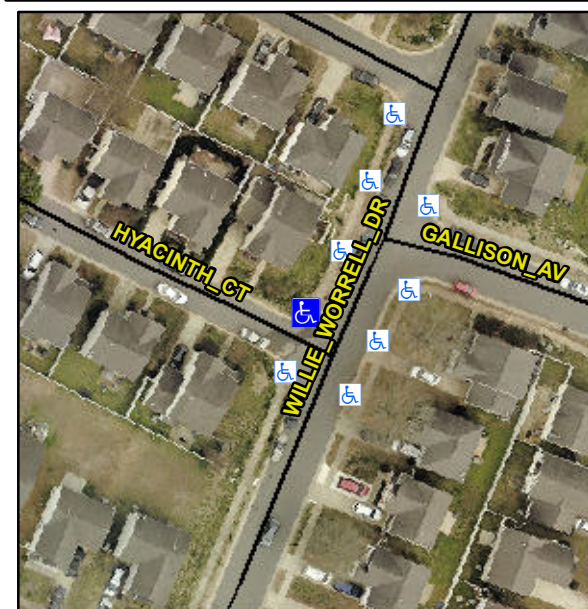
R304.5.1, R304.2.2, R304.5.3

Compliance	Description	Data	Compliance	Description	Data
N/A	Ramp Length (in)	47.0	No	Ramp Slope (%)	8.6
No	Ramp Width (in)	36.5	No	Ramp XSlope (%)	6.8
N/A	Flare Type LT	N/A	N/A	Flare Type RT	N/A
N/A	Flare Slope LT (%)	N/A	N/A	Flare Slope RT (%)	N/A
N/A	Flare Traversable LT?	N/A	N/A	Flare Traversable RT?	N/A
N/A	Landing Length (in)	N/A	N/A	DWS Provided?	N/A
N/A	Landing Width (in)	N/A	N/A	DWS Contrast?	N/A
N/A	Landing Slope (%)	N/A	N/A	DWS Length (in)	N/A
N/A	Landing X Slope (%)	N/A	N/A	DWS Full Width?	N/A
N/A	Landing Curb? (Y/N)	N/A	N/A	DWS Offset (in)	N/A
N/A	Shared Landing?	N/A			
N/A	Gutter Ponding?	N/A	N/A	Gutter Slope (%)	N/A
N/A	Gutter Lip Ht (in)	N/A	N/A	Gutter X Slope (%)	N/A
N/A	Painted X Walk1?	No	N/A	Painted X Walk2?	No
	X Walk 1 Direction	To SW		X Walk 2 Direction	To SE
N/A	X Walk 1 Width (in)	N/A	N/A	X Walk 2 Width (in)	N/A
	X Walk 1 Slope (%)	4.5		X Walk 2 Slope (%)	2.6
	X Walk 1 X Slope (%)	0.2		X Walk 2 X Slope (%)	3.1

N/A	Ramp inside XWalk1?	N/A	N/A	Ramp inside XWalk2?	N/A
	Road Slope (%)	2.9	N/A	Clear Space?	N/A
	Road X Slope (%)	4.5	N/A	Clear Space to XWalk (in)	N/A
N/A	Any Obstructions?	N/A	N/A	Storm Grate/Utility Hazard?	N/A
	Obstruction Type			Storm Grate/Utility Type	
		N/A			N/A
			Yes	Surface Condition? (G/P)	Good

Remove & Replace Curb Ramp With Two New Directional Ramps or Equivalent.
