# Access Compliance Report

## Public Rights-of-Way

### (Curb Ramps)

| Intersection ID: 13277 | Main Street: SPRUCE_ST | Cross Street: WILMORE_DR | Location: SE |

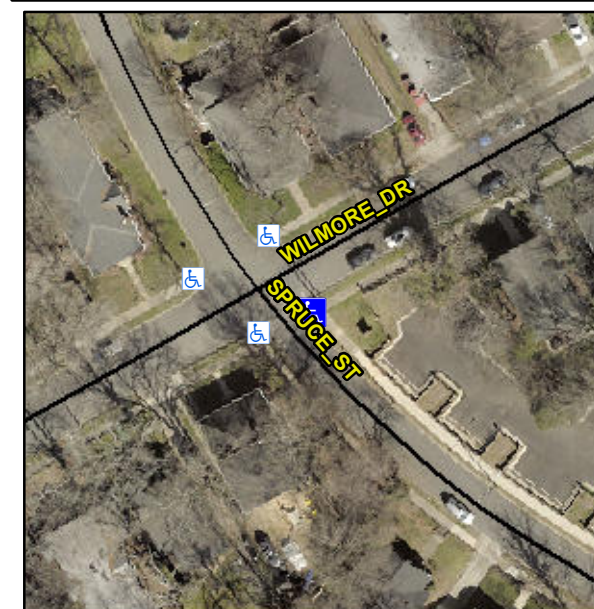
**Not Found, R304.2.2**

| Compliance | Description | Data | Compliance | Description | Data |
|---|---|---|---|---|---|
| N/A | Ramp Length (in) | 76.0 | No | Ramp Slope (%) | 9.4 |

**Remove & Replace Curb Ramp With Two New Directional Ramps or Equivalent.**
