Access Compliance Report Public Rights-of-Way (Curb Ramps)

Intersection ID: 46695Main Street: GOLDFIELDS_DRCross Street: TROTTERS_RIDGE_RDLocation:NEADA ID: 806131FB2768Ramp Type: PerpInitial Pass/Fail: FailOverall Compliance: NoSeverity Score: 13.75

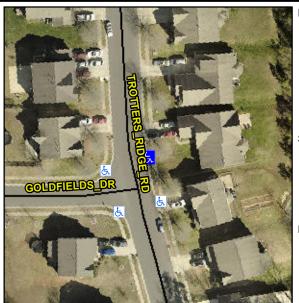
Field Measurements/Component Compliance							
Comp	liance Description	Data	Comp	liance	Description	Data	
N/A	Ramp Length (in)	46.0	No	Ramp	Slope (%)	9.4	
Yes	Ramp Width (in)	48.0	Yes	Ramp	XSlope (%)	3.2	
N/A	Flare Type LT	N/A	N/A	Flare	Type RT	N/A	
N/A	Flare Slope LT (%)	N/A	N/A	Flare	Slope RT (%)	N/A	
N/A	Flare Traversable LT?	N/A	N/A	Flare	Traversable RT?	N/A	
N/A	Landing Length (in)	N/A	N/A	DWS	Provided?	N/A	
N/A	Landing Width (in)	N/A	N/A	DWS	Contrast?	N/A	
N/A	Landing Slope (%)	N/A	N/A	DWS	Length (in)	N/A	
N/A	Landing X Slope (%)	N/A	N/A	DWS	Full Width?	N/A	
N/A	Landing Curb? (Y/N)	N/A	N/A	DWS	Offset (in)	N/A	
N/A	Shared Landing?	N/A					
N/A	Gutter Ponding?	N/A	N/A	Gutte	r Slope (%)	N/A	
N/A	Gutter Lip Ht (in)	N/A	N/A	Gutte	r X Slope (%)	N/A	
N/A	Painted X Walk1?	No	N/A	Paint	ed X Walk2?	N/A	
	X Walk 1 Direction	To W		X Wa	lk 2 Direction	N/A	
N/A	X Walk 1 Width (in)	N/A	N/A	X Wa	lk 2 Width (in)	N/A

X Walk 1 Slope (%)	3.8		X Wa	lk 2 Slope (%)	N/A	
	X Walk 1 X Slope (%)	5.5		X Wa	lk 2 X Slope (%)	N/A	
N/A	Ramp inside XWalk1?	N/A	N/A	Ram	inside XWalk2?	N/A	
	Road Slope (%)	N/A	N/A	Clear	Space?	N/A	
	Road X Slope (%)	N/A	N/A	Clear	Space to XWalk (in)	N/A	
N/A	Any Obstructions?	N/A	N/A	Storn	n Grate/Utility Hazard?	N/A	
	Obstruction Type			Storn	n Grate/Utility Type		
		N/A				N/A	
			Yes	Surfa	ce Condition? (G/P)	Good

Possible Solution	
Possible Solutions:	Compli
Remove & Replace Entire Ramp.	N/A
·	Yes
	N/A
	N/A
	N/A
	N/A
Surveyor Notes:	N/A
N/A	N/A
	N/A
	N/A
	N/A
PROW/ADA:	N/A
Not Found, R304.2.2	N/A
·	N/A
	N/A
	N/A
