Access Compliance Report

Public Rights-of-Way

(Curb Ramps)

Intersection ID: 7008	Main Street: MCALLISTER_DR	Cross Street: MERRILL_PL	Location: NE
ADA ID: 80633F327B13	Ramp Type: BlendTrans2	Initial Pass/Fail: Fail	Overall Compliance: No
		Severity Score: 25

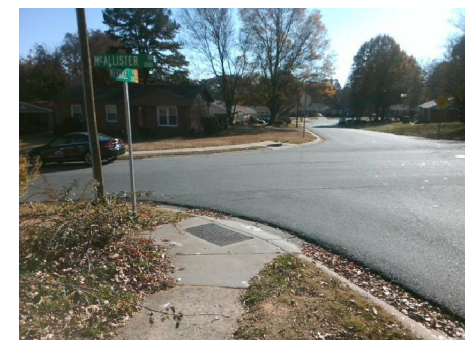
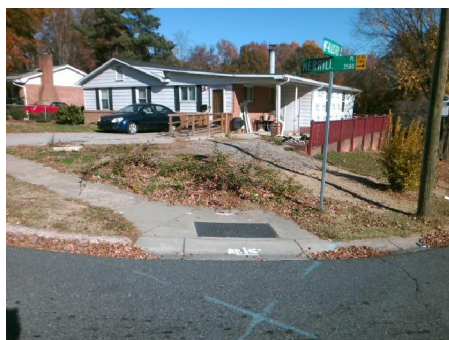
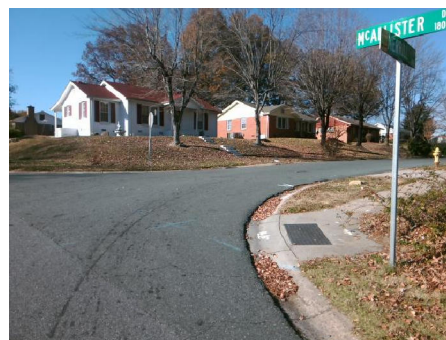
Compliance	Description	Data	Compliance	Description	Data
N/A	Ramp Length (in)	57.0	Yes	BlendTrans Slope (%)	4.2
Yes	Ramp Width (in)	62.0	No	BlendTrans XSlope (%)	8.1
N/A	Flare Type LT	N/A	N/A	Flare Type RT	N/A
N/A	Flare Slope LT (%)	N/A	N/A	Flare Slope RT (%)	N/A
N/A	Flare Traversable LT?	N/A	N/A	Flare Traversable RT?	N/A
N/A	Landing Length (in)	N/A	N/A	DWS Provided?	N/A
N/A	Landing Width (in)	N/A	N/A	DWS Contrast?	N/A
N/A	Landing Slope (%)	N/A	N/A	DWS Length (in)	N/A
N/A	Landing X Slope (%)	N/A	N/A	DWS Full Width?	N/A
N/A	Landing Curb? (Y/N)	N/A	N/A	DWS Offset (in)	N/A
N/A	Shared Landing?	N/A			
N/A	Gutter Ponding?	N/A	N/A	Gutter Slope (%)	N/A
N/A	Gutter Lip Ht (in)	1.0	N/A	Gutter X Slope (%)	N/A
N/A	Painted X Walk1?	No	N/A	Painted X Walk2?	N/A
	X Walk 1 Direction	To S		X Walk 2 Direction	N/A
	X Walk 1 Width (in)	N/A		X Walk 2 Width (in)	N/A
	X Walk 1 Slope (%)	1.6		X Walk 2 Slope (%)	N/A
	X Walk 1 X Slope (%)	6.6		X Walk 2 X Slope (%)	N/A

N/A	Ramp inside XWalk1?	N/A	N/A	Ramp inside XWalk2?	N/A
	Road Slope (%)	6.6		Clear Space?	N/A
	Road X Slope (%)	1.6	N/A	Clear Space to XWalk (in)	N/A
N/A	Any Obstructions?	N/A	N/A	Storm Grate/Utility Hazard?	N/A
	Obstruction Type			Storm Grate/Utility Type	
		N/A			N/A
			Yes	Surface Condition? (G/P)	Good
			No	Curb Slope (%)	21.3

Remove & Replace Curb Ramp With Two New Directional Ramps or Equivalent.
