Access Compliance Report

Public Rights-of-Way

(Curb Ramps)

Intersection ID: 43643	Main Street: HUNTINGTON_MEADOW_LN	Cross Street: SOUTHFIELD_DR	Location: SE
ADA ID: 8064A4DE9F9F	Ramp Type: Perp	Initial Pass/Fail: Fail	Overall Compliance: No
Severity Score: 12.5			
Codes/Mitigation Info/Possible Solution		Field Measurements/Component Compliance

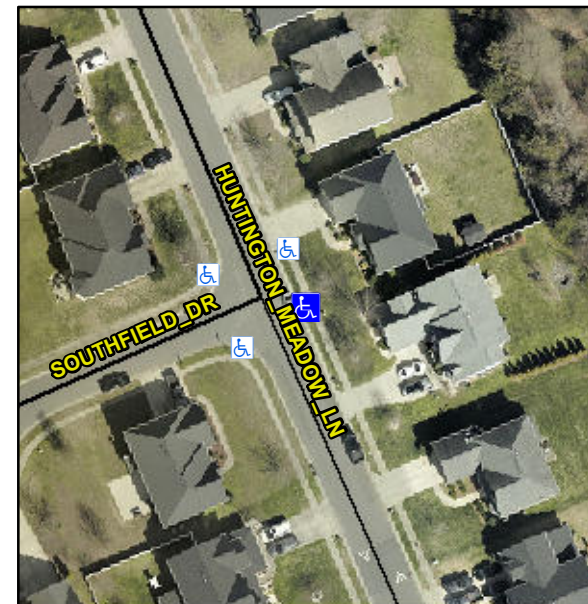
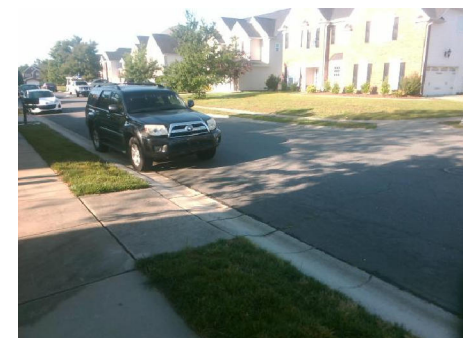
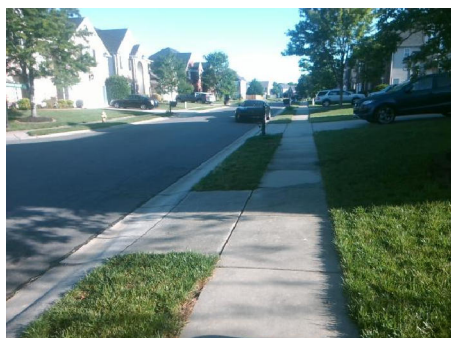
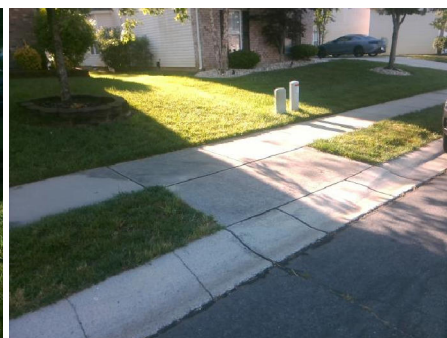
Not Found, R304.2.2

Compliance	Description	Data	Compliance	Description	Data
N/A	Ramp Length (in)	45.0	No	Ramp Slope (%)	9.5
Yes	Ramp Width (in)	48.0	Yes	Ramp XSlope (%)	1.9
N/A	Flare Type LT	N/A	N/A	Flare Type RT	N/A
N/A	Flare Slope LT (%)	N/A	N/A	Flare Slope RT (%)	N/A
N/A	Flare Traversable LT?	N/A	N/A	Flare Traversable RT?	N/A
N/A	Landing Length (in)	N/A	N/A	DWS Provided?	N/A
N/A	Landing Width (in)	N/A	N/A	DWS Contrast?	N/A
N/A	Landing Slope (%)	N/A	N/A	DWS Length (in)	N/A
N/A	Landing X Slope (%)	N/A	N/A	DWS Full Width?	N/A
N/A	Landing Curb? (Y/N)	N/A	N/A	DWS Offset (in)	N/A
N/A	Shared Landing?	N/A			
N/A	Gutter Ponding?	N/A	N/A	Gutter Slope (%)	N/A
N/A	Gutter Lip Ht (in)	N/A	N/A	Gutter X Slope (%)	N/A
N/A	Painted X Walk1?	No	N/A	Painted X Walk2?	N/A
	X Walk 1 Direction	To W		X Walk 2 Direction	N/A
N/A	X Walk 1 Width (in)	N/A	N/A	X Walk 2 Width (in)	N/A
	X Walk 1 Slope (%)	2.6		X Walk 2 Slope (%)	N/A
	X Walk 1 X Slope (%)	1.4		X Walk 2 X Slope (%)	N/A

N/A	Ramp inside XWalk1?	N/A	N/A	Ramp inside XWalk2?	N/A
	Road Slope (%)	N/A	N/A	Clear Space?	N/A
	Road X Slope (%)	N/A	N/A	Clear Space to XWalk (in)	N/A
N/A	Any Obstructions?	N/A	N/A	Storm Grate/Utility Hazard?	N/A
	Obstruction Type			Storm Grate/Utility Type	
		N/A			N/A
			Yes	Surface Condition? (G/P)	Good

Possible Solutions:

Remove & Replace Entire Ramp.

Total Cost: \$ 1850.00
