Access Compliance Report

Public Rights-of-Way

(Curb Ramps)

Intersection ID: 10034319	Main Street: PERIMETER_PY	Cross Street: N/A	Location: NW
ADA ID: 80698AA21D32	Ramp Type: PerpDiag	Initial Pass/Fail: Fail	Overall Compliance: No
		Severity Score: 10

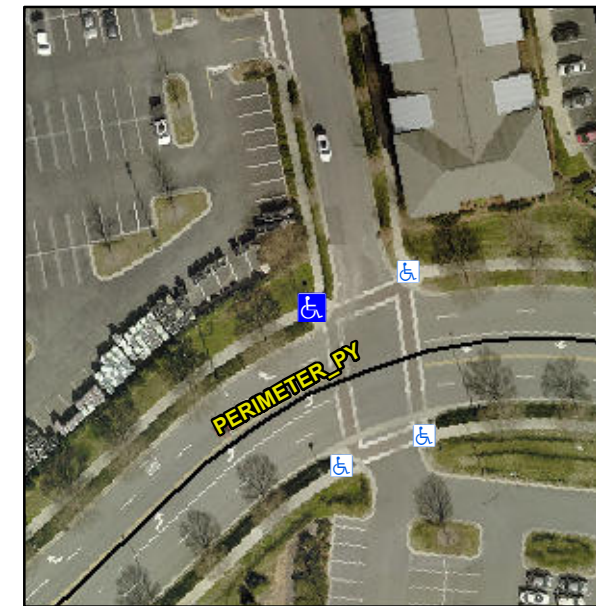
Not Found, R304.5.1, R304.5.3

Compliance	Description	Data	Compliance	Description	Data
N/A	Ramp Length (in)	67.0	Yes	Ramp Slope (%)	8.2
No	Ramp Width (in)	47.0	No	Ramp XSlope (%)	2.9
N/A	Flare Type LT	N/A	N/A	Flare Type RT	N/A
N/A	Flare Slope LT (%)	N/A	N/A	Flare Slope RT (%)	N/A
N/A	Flare Traversable LT?	N/A	N/A	Flare Traversable RT?	N/A
N/A	Landing Length (in)	N/A	N/A	DWS Provided?	N/A
N/A	Landing Width (in)	N/A	N/A	DWS Contrast?	N/A
N/A	Landing Slope (%)	N/A	N/A	DWS Length (in)	N/A
N/A	Landing X Slope (%)	N/A	N/A	DWS Full Width?	N/A
N/A	Landing Curb? (Y/N)	N/A	N/A	DWS Offset (in)	N/A
N/A	Shared Landing?	N/A			
N/A	Gutter Ponding?	N/A	N/A	Gutter Slope (%)	N/A
N/A	Gutter Lip Ht (in)	N/A	N/A	Gutter X Slope (%)	N/A
N/A	Painted X Walk1?	Yes	N/A	Painted X Walk2?	Yes
	X Walk 1 Direction	To S		X Walk 2 Direction	To E
N/A	X Walk 1 Width (in)	72.0	N/A	X Walk 2 Width (in)	72.0
	X Walk 1 Slope (%)	1.8		X Walk 2 Slope (%)	0.4
	X Walk 1 X Slope (%)	2.7		X Walk 2 X Slope (%)	0.8

N/A	Ramp inside XWalk1?	Yes	N/A	Ramp inside XWalk2?	Yes
	Road Slope (%)	4.0	N/A	Clear Space?	N/A
	Road X Slope (%)	1.2	N/A	Clear Space to XWalk (in)	N/A
N/A	Any Obstructions?	N/A	N/A	Storm Grate/Utility Hazard?	N/A
	Obstruction Type			Storm Grate/Utility Type	
		N/A			N/A
		Yes		Surface Condition? (G/P)	Good

Possible Solutions:

Remove & Replace Curb Ramp With Two New Directional Ramps or Equivalent.
